# FULL RESERVE STUDY

## Brickyard at Wellington Homeowners Association

**Grand Junction, Colorado**  
**February 4, 2022**

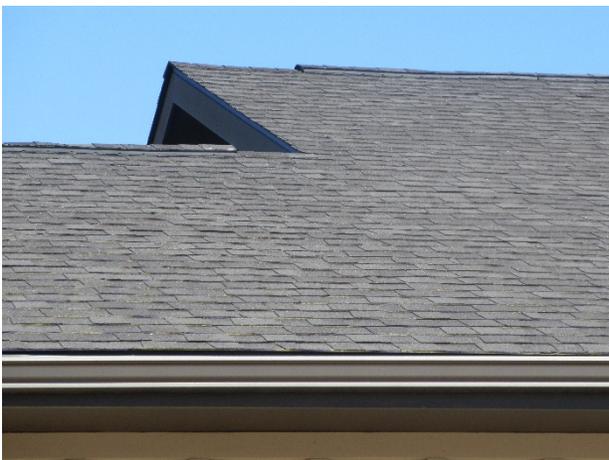
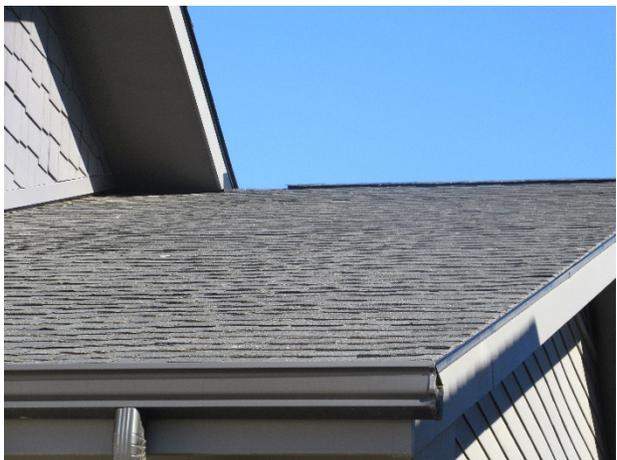
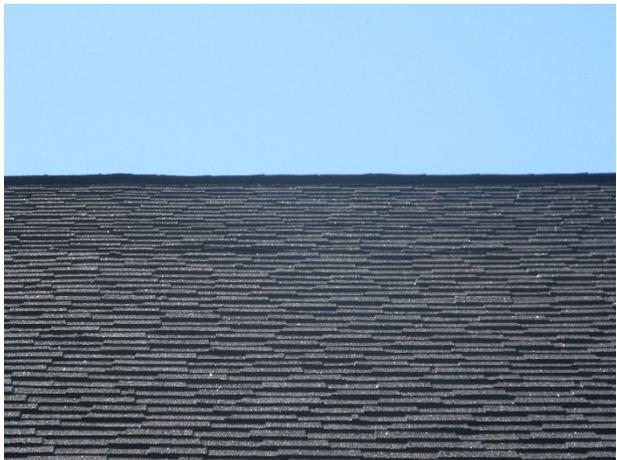
**Condition:** Good overall with isolated shingle lift evident from our visual inspection from the ground. Management does not report a history of leaks.

**Shingle lift**

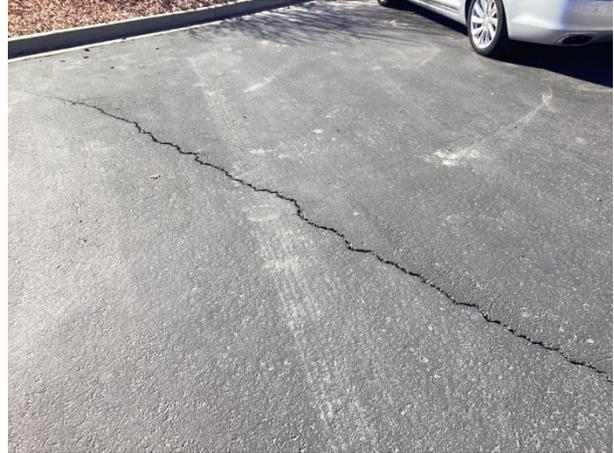
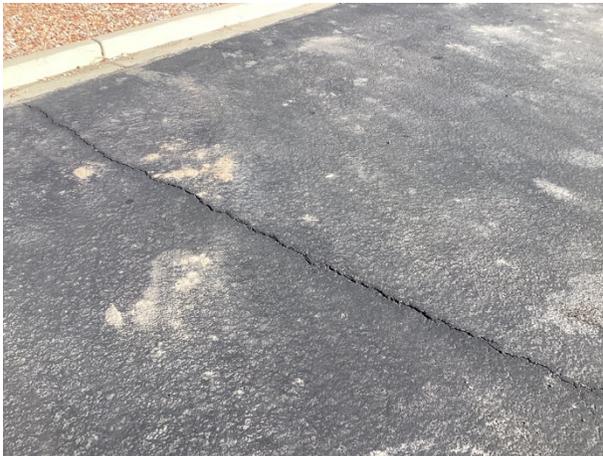
**Condition:** Good overall with pavement and concrete curb and gutter cracks evident

**Pavement cracks**

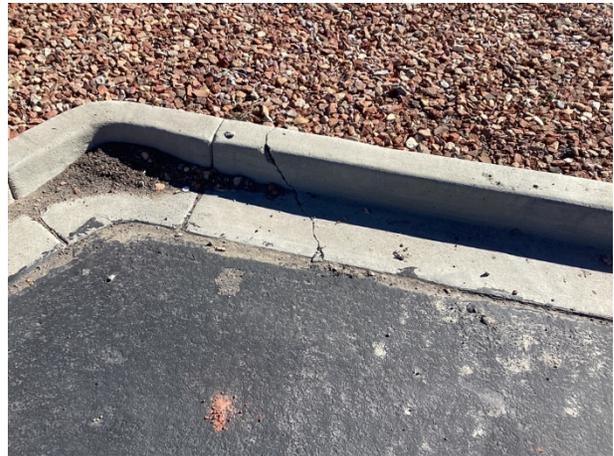
**Concrete curb and gutter crack**

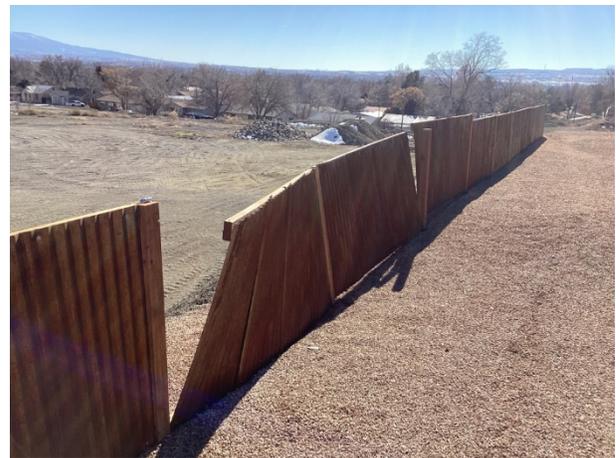
**Condition:** Good overall with isolated leaning sections evident

Wood frame with steel fence overview: Note fence leaning sections

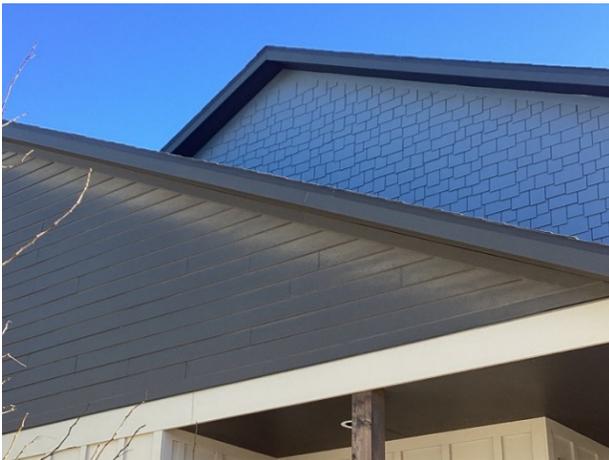
**Condition:** The paint finishes are in good overall condition with isolated finish deterioration and siding damage evident.

**Finish deterioration**

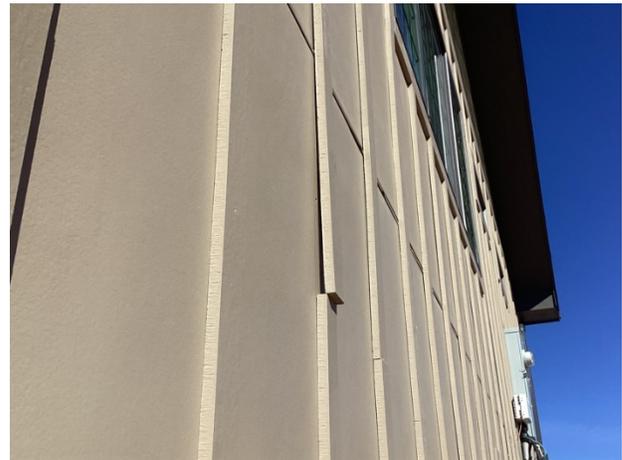
**Siding damage**

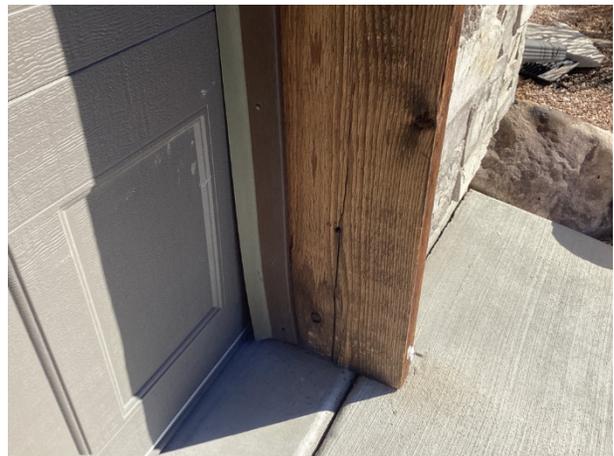
**Condition:** Good overall with isolated split wood trim evident

**Split wood trim**
