**Sundance Crossing OA**  
***Grand Junction, CO***

Report #: 48495-0  
Beginning: January 1, 2024  
Expires: December 31, 2024

**RESERVE STUDY**  
**"Full"**

August 30, 2023

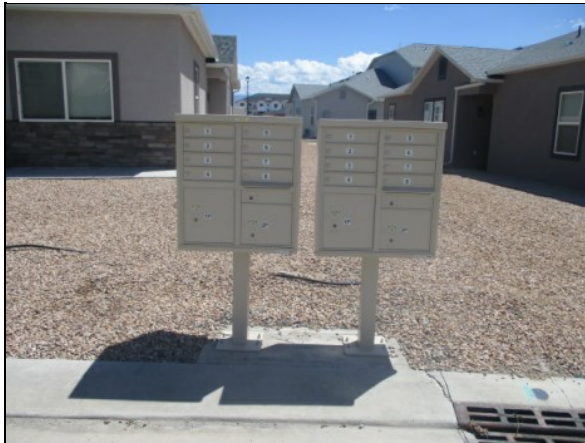
Comments: Mailbox kiosks determined to be in good condition typically exhibit a uniform appearance without much surface wear. Hardware appears to be in good condition and boxes/panels appear to close and lock properly. Appearance and style are consistent with the aesthetic standards of the development. Inspect regularly and clean by wiping down exterior surfaces. If necessary change lock cylinders lubricate hinges and repair as an Operating expense. Best to plan for total replacement at roughly the time frame below due to constant exposure usage and wear over time. Note USPS has a limited budget for replacement and should not be relied upon for purposes of long term planning.
