## Shadow Run Townhomes *Grand Junction, CO*

Report #: 14323-1  
Beginning: January 1, 2026  
Expires: December 31, 2026

# RESERVE STUDY

February 20, 2026

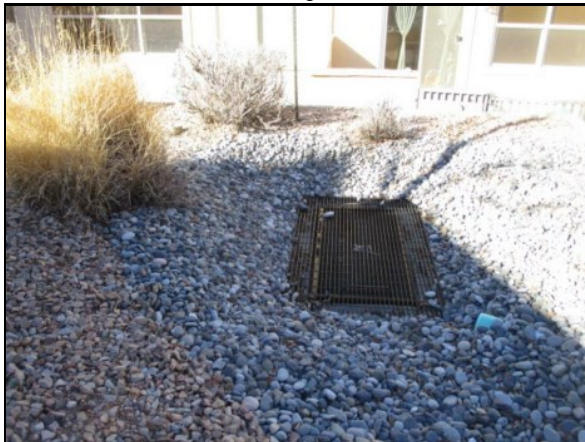
**Comments:** Some municipalities require permitted stormwater drainage systems to be inspected on a regular basis with preventive maintenance and repair work completed as needed. Our inspection is not intended to comply with this requirement but some Clients choose to list the expense of the process as a Reserve component. Cost of this project is reported to be considered an Operating expense. No recommendation for Reserve funding at this time.

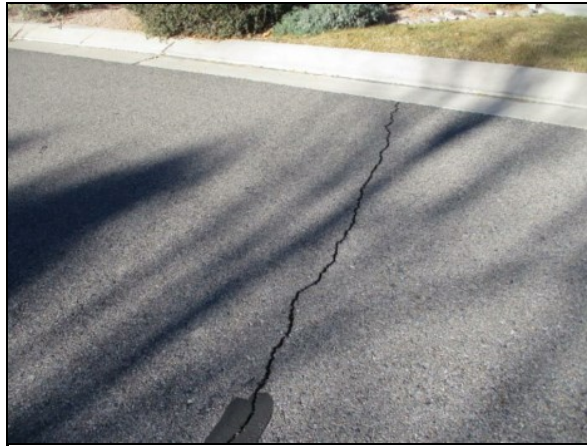
**Comp #: 21190 Asphalt - Seal/Repair****Approx Quantity: 36,800 GSF****Location:** Common Areas**Funded?:** Yes.**History:**

**Remaining Life:**

0 years

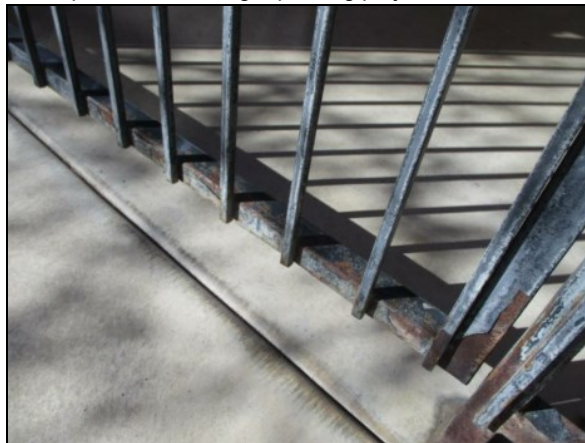
**Comments:** No specific recommendation for funding for painting or re-coating which is expected to be completed as needed as an Operating expense or as part of scope of work for larger painting projects within the development.

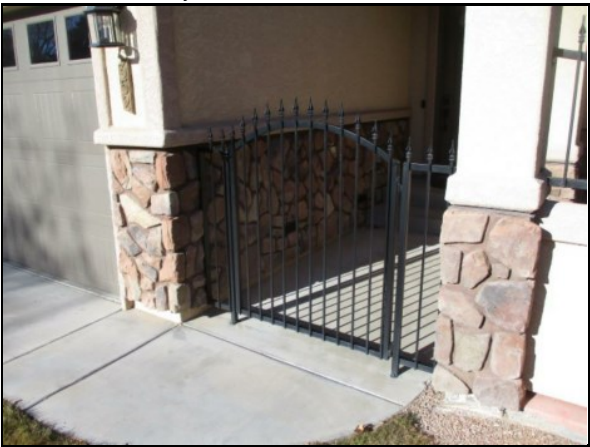
Comp #: 21310 Site Rail: Metal - Replace

Useful Life:  
30 years

Remaining Life:  
10 years

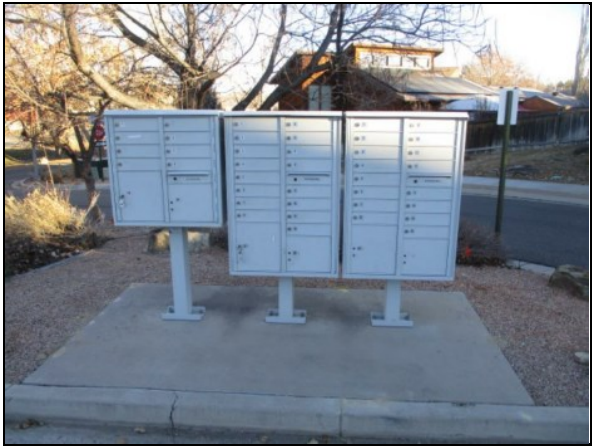
**Comp #: 21600 Mailbox Kiosks - Replace**

**Useful Life:**  
30 years

**Remaining Life:**  
10 years

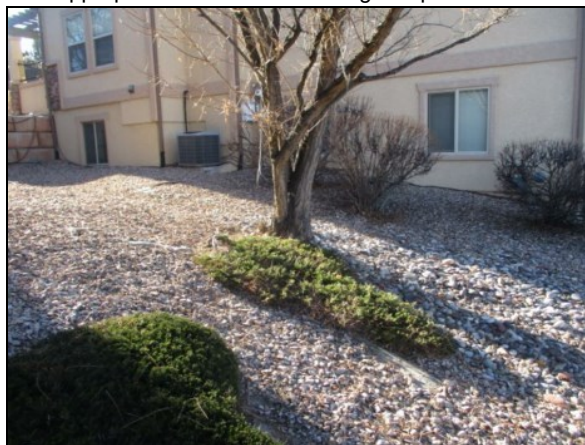
**Comments:** In general costs related to this component are expected to be included in the client's Operating budget. No recommendation for Reserve funding at this time. However any repair and maintenance or other related expenditures should be tracked and this component should be re-evaluated during future Reserve Study updates based on most recent information and data available at that time. If deemed appropriate for Reserve funding component can be included in the funding plan at that time.

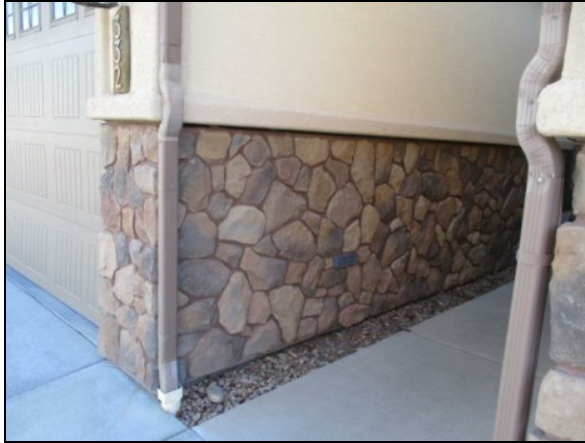
**Comments:** Brick or other masonry siding is typically a low maintenance surface that requires minimal infrequent repair. However in some cases (usually after several decades or more) the original mortar between bricks may require repointing to restore appearance and adequately protect against water intrusion. Repointing involves raking out a portion of the existing mortar and installing new mortar and continuing on until all affected sections have been replaced. In our experience there is not a well-defined predictable timeline for repointing work usually making this project inappropriate for Reserve funding. If re-pointing is a concern we strongly recommend further inspection by a qualified engineer and/or masonry specialist to diagnose existing conditions and recommend a scope of work. If warranted the Reserve Study can be adjusted to include funding recommendations going forward.

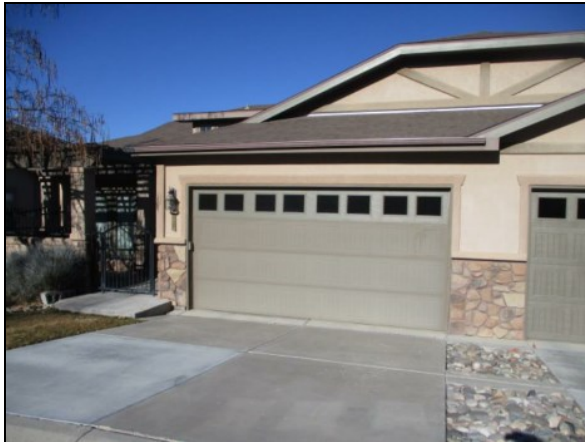
**Comments:** Based on limited review of the client's governing documents, individual owners are believed to be responsible for garage door replacement. However, our review is not intended to be a professional legal opinion and we reserve the right to revise this component if the client is otherwise found to be responsible for replacement. No recommendation for Reserve funding at this time.
