LEVEL 1 REPLACEMENT RESERVE REPORT FY 2025 COUNTRY CREEK PATIO HOME ASSOCIATION, INC.

COUNTRY CREEK PATIO HOME ASSOCIATION, INC.

FRUITA, COLORADO
December 02, 2024
Revised March 18, 2025

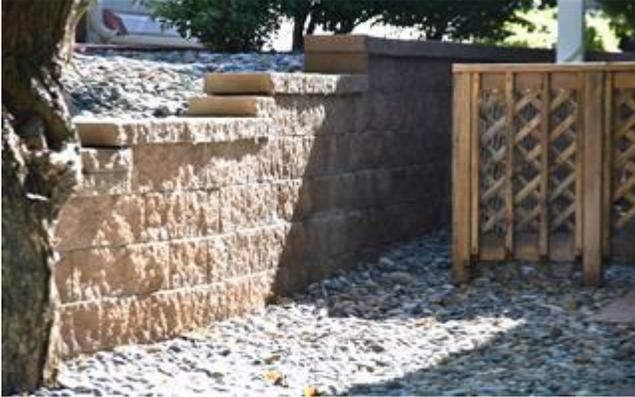
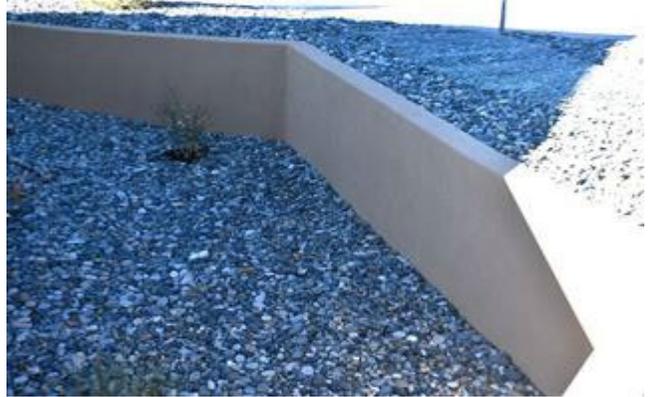
Segmental Block. Segmental block retaining walls can have an extended useful life, and if stable, are likely to only require localized resetting of displaced blocks, typically near the top of the wall. This study assumes that resetting will be performed incrementally as needed.

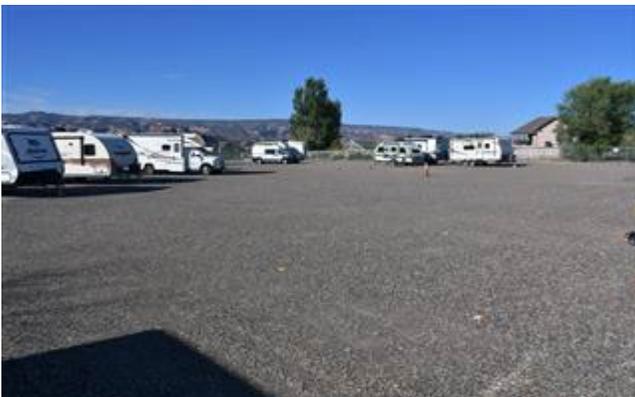
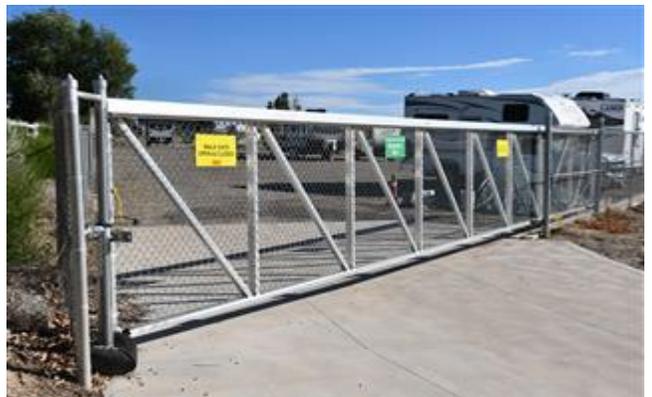
RV Storage Area. The Association maintains an RV Storage Area that includes gravel rv parking area, chain link fencing, and manual security gate that were recently constructed and appear to be in good condition. The gravel lot was recently constructed. The gravel will need to be reconstituted and graded around the 10 year timeframe. The gravel lot was recently constructed. The gravel will need to be reconstituted and graded around the 10-year timeframe. Chain link fencing can have a useful life of 40 years or more. Periodic repair or replacement of posts or top rails may be required as regular maintenance. There is also an aluminum framed security gate which is manually operated. The study assumes the gate will last the life of the chain line fencing and be replaced at the same timeframe.

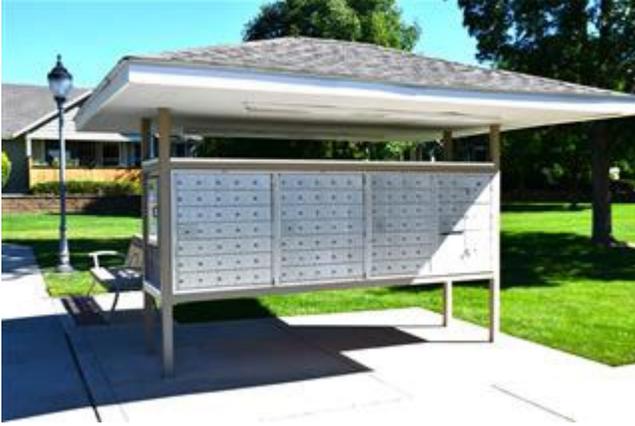
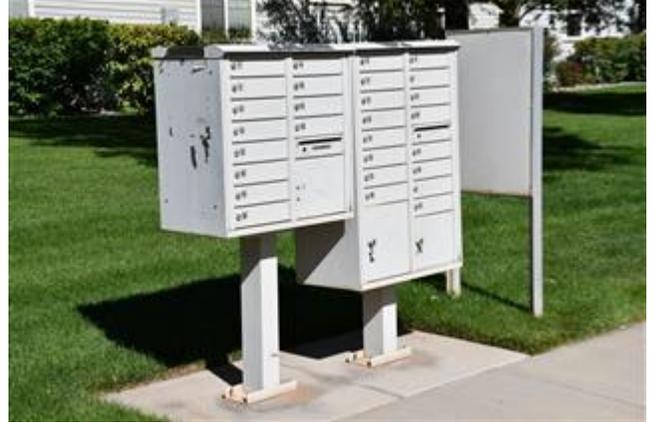
Mailbox Enclosure & Mailbox Clusters. The Association is responsible for a mailbox center which consists of a metal frame that secures the aluminum mailbox clusters and a roof for weather protection. The mailbox center appears to be in fair condition.

There are also two mailbox clusters mounted on pedestals, a 16-bay and a 12-bay unit. The existing units appear to be metal enclosures with metal doors. The study assumes the replacement units will be composite units.

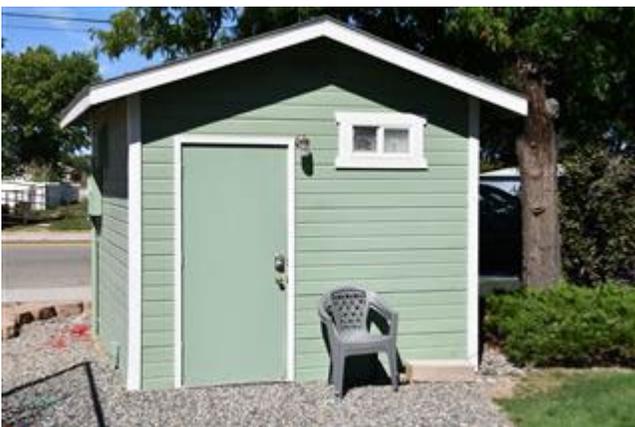
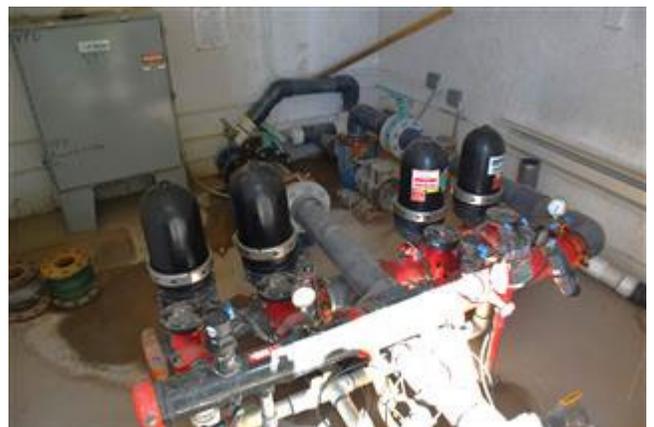
The irrigation pumps, VFD, and filtration assembly should have a useful life of approximately 25 years. The study models the replacement at 25 years with a pump motor replacement for the larger 15-hp pump halfway through the systems life.

North Pumphouse. The north pumphouse building consists of SSMR roofing, siding, door, and garage door. The building appears to be in good condition. The components within the building include a filtration system, single pump, and a single VFD drive.

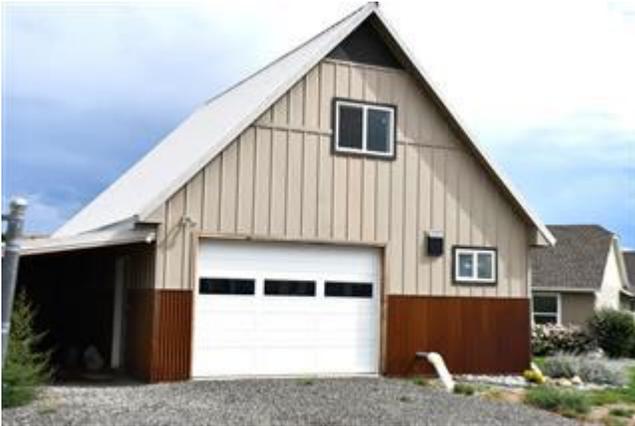
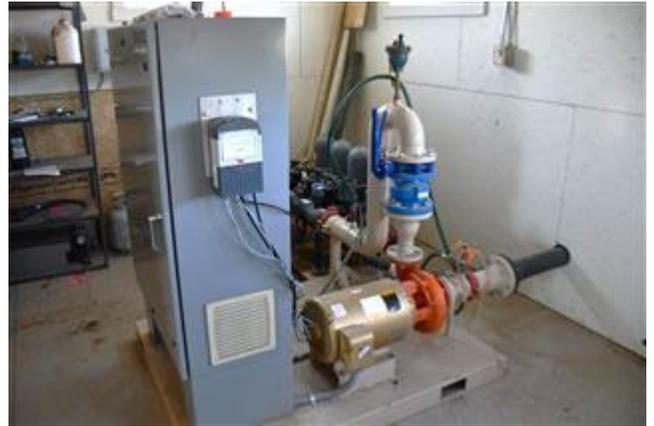
The irrigation pump, VFD, and filtration assembly should have a useful life of approximately 25 years. The study models the replacement at 25 years with a pump motor replacement for the 20-hp pump halfway through the systems life.

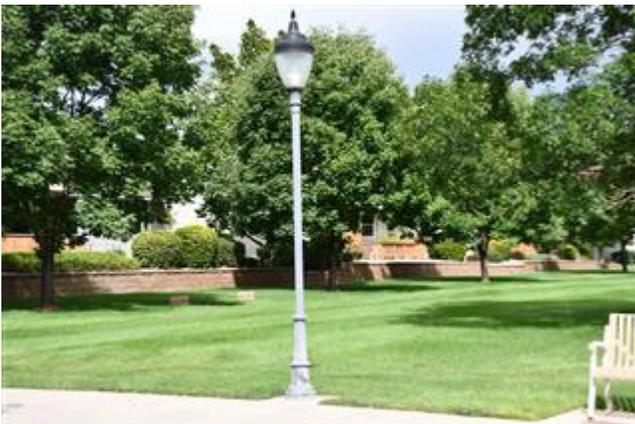
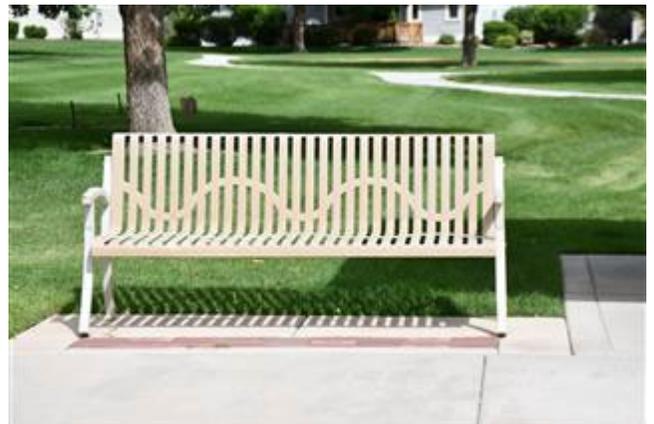
The community flagpole has an expected useful life of 50 years while the pole lights have a 20 to 25 year useful life. One of the two pole lights has already failed (at its base) and it appears the pole lights are at the end of their useful life.

The metal benches have been installed recently and have a life expectancy of 25 to 30 years. The horseshoe courts should last approximately 20 years while the barbecue grills should have a life expectancy of 10 years.

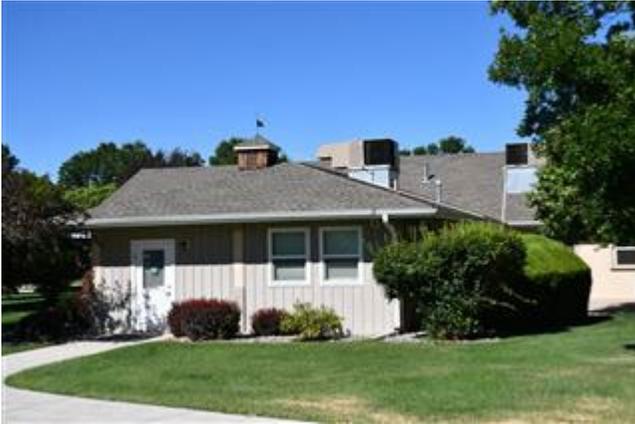
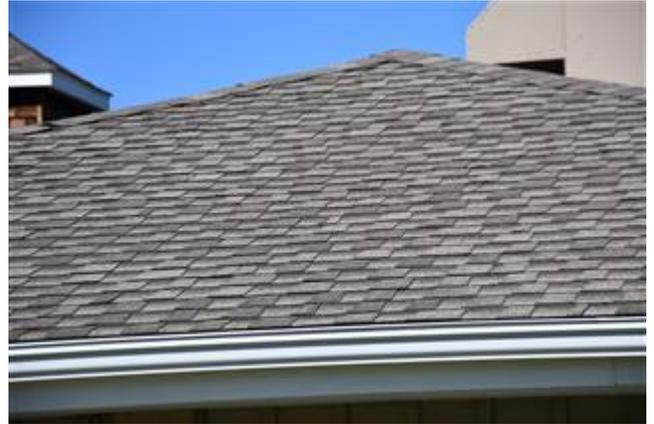
Roofing, Asphalt Shingles. The buildings

Asphalt shingle roofs can have a useful life of 20 to 50 years, depending on the weight and quality of the shingle. Weathered, curled, and missing shingles indicate they may be nearing the end of their useful life. A solution to consider for the next roofs is a stone-coated metal roof. The stone-coated metal can even be installed with a shake profile that looks just like a wood shake.

These roofs come with a lifetime warranty against wind and hail damage. A couple of manufacturers of stone-coated metal roofs are Gerard and Allmet Roofing. For purposes of the reserve study, we have modeled a standard asphalt roof. The model could be altered to a stone-coated roof that looks like an asphalt shingle in style or even one with a shake profile instead. The installation of a stone-coated metal roof will also significantly lower the Associations insurance rate by as much as 30 to 35%.

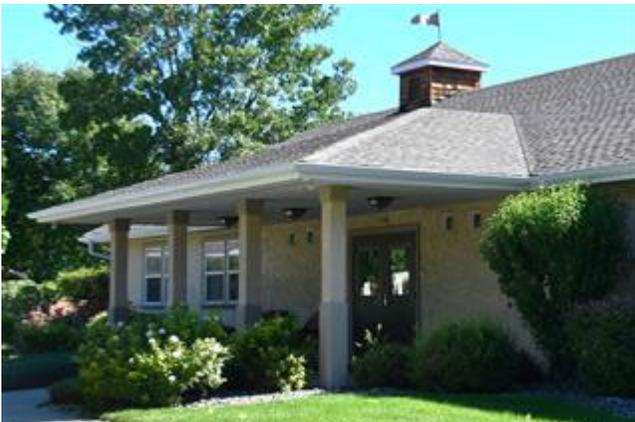
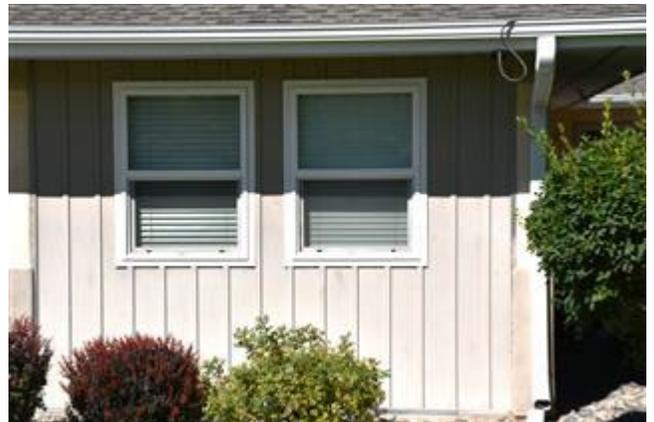
Gutters and Downspouts. The Community Center has aluminum gutters and downspouts. The gutters and downspouts appear to be in good condition.

It is recommended that all gutters be cleaned at least twice each year. If there are a large number of trees located close to a building, consider installing a gutter debris shield that will let water into the gutters but will filter out leaves, twigs, and other debris.

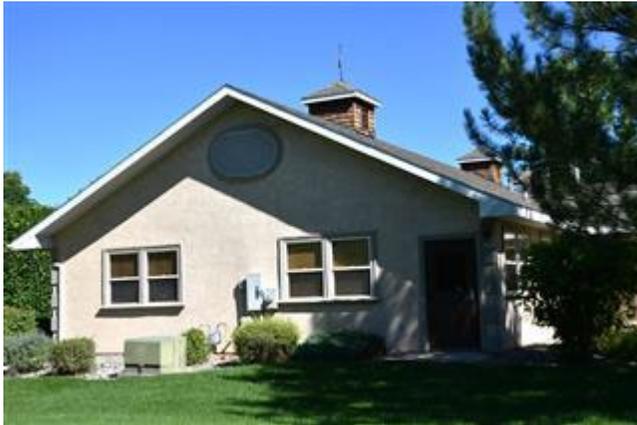
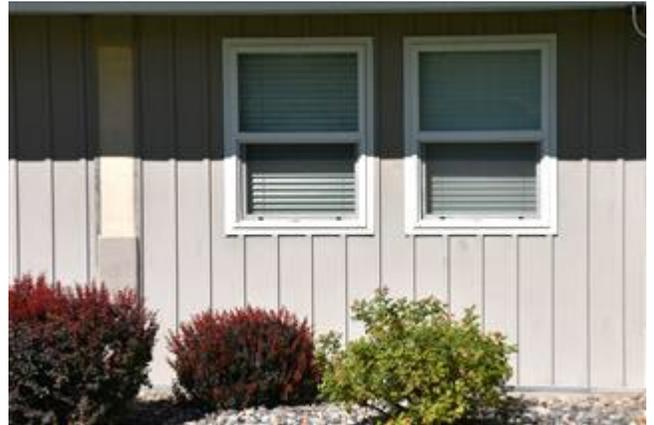
Siding, Cementitious. The Community Center has both siding and stucco. Both appear to be in good condition. The wood exterior siding and trim appear to be in good condition. Wooden exterior materials useful life of approximately 25 to 30 years. Painting or stain cycles (and other maintenance) can extend the useful life of the wood. When it is time to replace the wood siding the Association should consider replacement using low-maintenance synthetic or cementitious materials as an alternative to high-maintenance materials. Cementitious materials typically have an extended useful life and require repainting and recaulking every 10 to 15 years. Following the manufacturer's recommendations for cleaning, painting, and caulking, we expect cementitious products to have a useful life of 50 years or more.

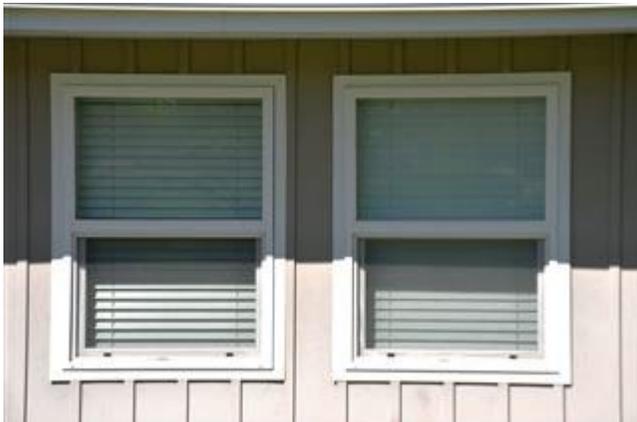
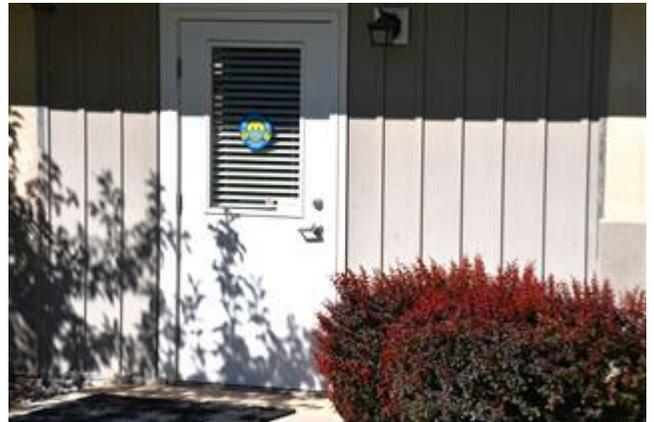
Stucco Siding. Stucco finishes are installed on the facility's exterior. Most stucco deterioration is the result of water infiltration. This is generally first evident near the roof and around chimneys, windows, doors, and other wall penetrations. Moisture can also gain access through materials that are in contact with the ground by a process called wicking. Moisture will cause the supporting lath for the stucco to rot or corrode, resulting in the stucco pulling away from the substrate. Significant deterioration of wooden and metal structural elements can occur. Similar to Exterior Insulation Finishing Systems (EIFS), a "water-managed system" is the approach for new construction. However, many older installations assume a water barrier system. It is recommended that all stucco surfaces be inspected at least once each year. In this study, we provide an allowance for incremental stucco repairs every ten years with a recoating every 20 years. Further inspection of the stucco and repair of any latent and concealed damage are not accounted for in this study.

In general, we recommend coordinating the replacement of these units with other exterior work, such as siding and roof replacements. The weather tightness of the building envelope often requires transitional flashing and caulking that should be performed in coordination. Warranties and advantages in 'economy of scale' can often result in lower overall replacement costs and more reliable results. Lastly, coordinated replacements offer the opportunity to correct initial construction defects and improve the effectiveness of details with improved construction techniques and materials.

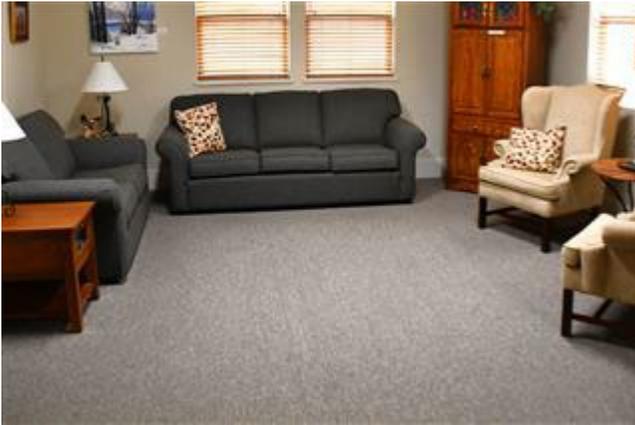
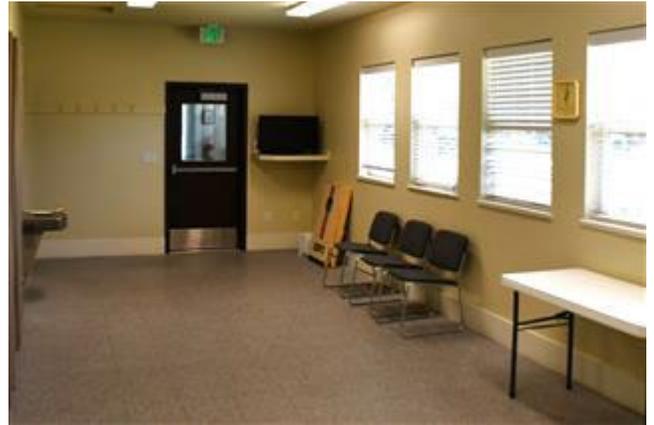
Vinyl Plank. The part of the Community Center that does not have carpet contains vinyl tiles. The tiles are in fair condition. When they tiles are finally replaced it is recommended the Association utilize either wood or vinyl plank. This material will last longer and has better aesthetic options.

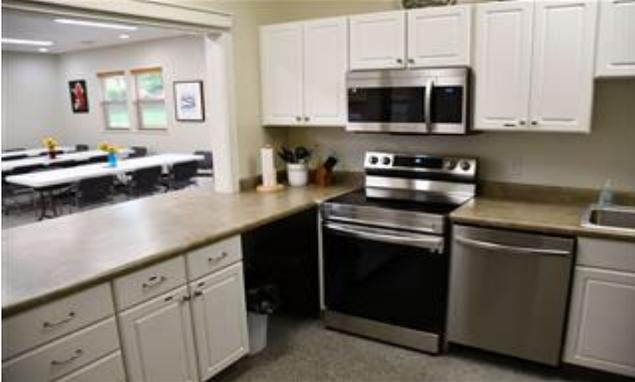
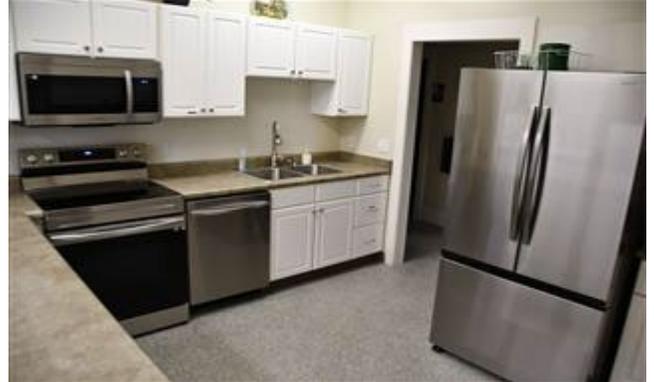
Kitchen Renovation. The Community Center has a kitchen that contains millwork, counter tops, and appliances. There is also millwork in the party room and the pool room. The kitchen appliances are fairly new and appear to be in good condition. The millwork and counter tops appear to be original and in fair condition. There is a possibility the Community Center will receive a full renovation. If that happens the counter tops would be replaced and the millwork (cabinets) could either be replaced or at least refaced with new cabinet doors.

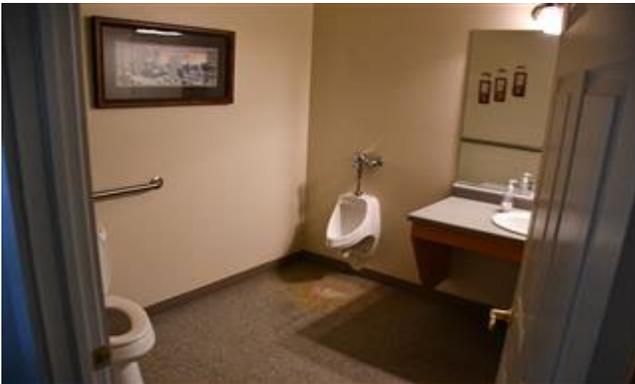
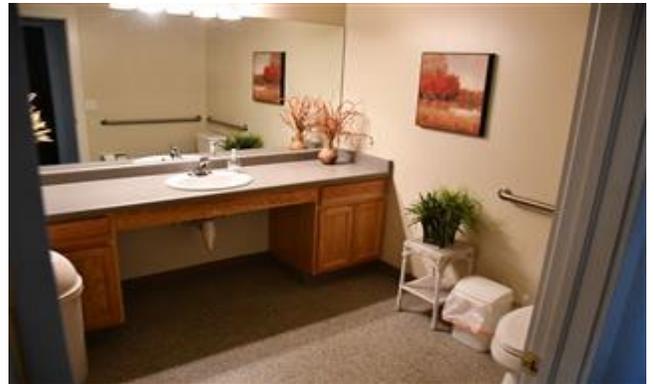
Restrooms. The restrooms for the Community Center consist of a Mens, Womens, and Fitness Area restroom that all appear to be in overall fair condition.

- Floor Tile. Covered above.
- Light Fixtures. Covered above.
- Shower and Restroom Fixtures. All shower and restroom fixtures appear to be in fair condition. We have assumed a service life of 20 years for the fixtures and that all fixtures will be replaced simultaneously as part of general restroom renovation.
