Red Rock Valley  
*Grand Junction, CO*

Report #: 53935-0  
Beginning: January 1, 2025  
Expires: December 31, 2025

RESERVE STUDY  
"Full"

December 17, 2024

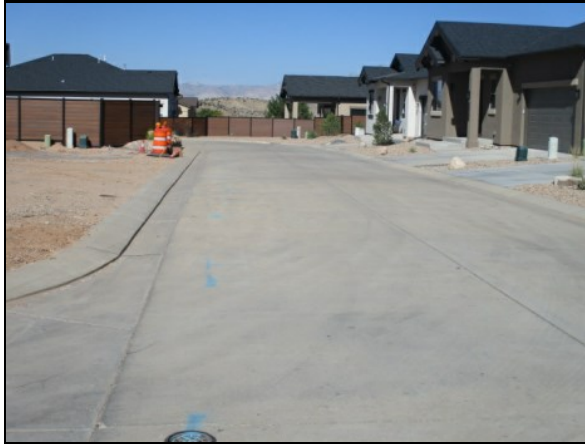
**Comp #:** 21050 Drive Concrete - Repair - 5%

Comments: Concrete driveways determined to be in fair condition typically may exhibit small changes in slope and narrow "hair-line" wide cracks. Overall no unusual or extreme signs of age noted. Driveways are reported to be the maintenance and repair responsibility of the client. Although complete replacement of all areas together should not be required conditions observed merit inclusion of an allowance for ongoing repairs and partial replacements. Exposure to sunlight weather and frequent vehicle traffic can lead to larger more frequent repairs especially for older properties. Inspect all areas periodically to identify trip hazards or other safety issues. Timeline and cost ranges shown here should be re-evaluated during future Reserve Study updates.

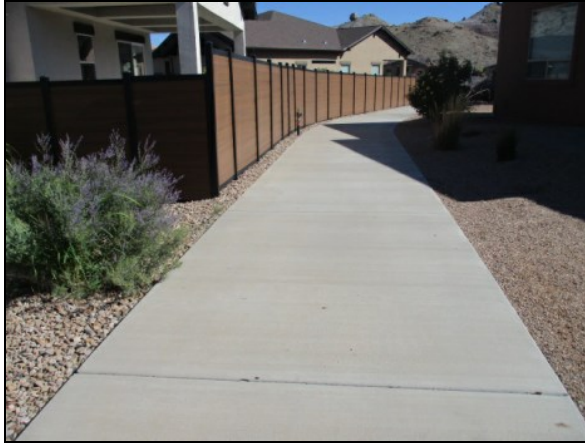
**Comp #: 21090 Concrete Walkways - Repair - 5%**

Comments: Concrete sidewalks determined to be in fair condition typically exhibit minor changes in slope and a moderate percentage of cracking and surface wear. Trip hazards may be increasing in frequency and severity and should be closely monitored to prevent further risks. The Rocky Mountain Region is home to expansive soils. One of the causes of concrete damage in this type of climate is soil moisture. Expansive soils tend to swell in size when wet and contract as they dry out. As the soil expands and contracts it can create enough force to cause major damage to sidewalks. Repair any trip and fall hazards immediately to ensure safety. As routine maintenance inspect regularly pressure wash for appearance and repair promptly as needed to prevent water penetrating into the base and causing further damage. In our experience larger repair/replacement expenses emerge as the community ages. Although difficult to predict timing cost and scope we suggest a rotating funding allowance to supplement the operating/maintenance budget for periodic larger repairs. Adjust as conditions actual expense patterns dictate within future reserve study updates.

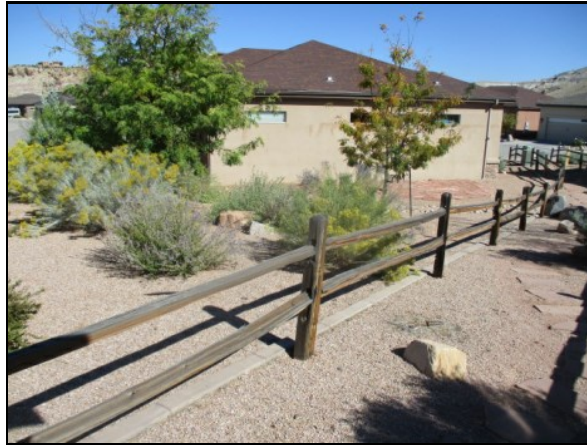
**Comp #: 21320 Site Fencing: Wood - Repair/Stain**

Comments: Wood fencing determined to be in poor condition typically exhibits more advanced deterioration of coating with notable wear possibly resulting in rotting of wood structure in places. Poor inconsistent curb appeal. Regular uniform professional paint or sealer applications are recommended for appearance protection of wood and maximum design life. Repair as needed and clean prior to application. Regular uniform, professional paint or sealer applications are recommended for appearance, protection of wood and maximum design life. In general, costs related to this component are expected to be included in the client's Operating budget. No recommendation for Reserve funding at this time. However, any repair and maintenance or other related expenditures should be tracked, and this component should be re-evaluated during future Reserve Study updates based on most recent information and data available at that time. If deemed appropriate for Reserve funding, component can be included in the funding plan at that time.

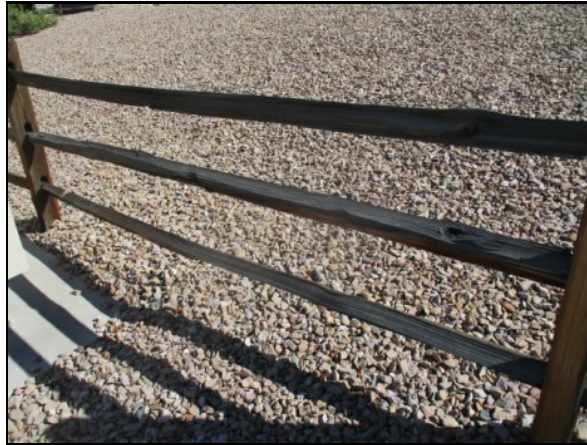
**Comp #: 21340 Site Fencing: Wood Rail - Replace**

Comments: Wood fencing determined to be in fair condition typically exhibits some minor to moderate amounts of surface wear and other signs of age which may include a small percentage of warped split and/or rotted sections. In general appearance is consistent but declining. As routine maintenance inspect regularly for any damage repair as needed and avoid contact with ground and surrounding vegetation wherever possible. Regular cycles of uniform professional sealing/painting will help to maintain appearance and maximize life. In our experience wood fencing will typically eventually break down due to a combination of sun and weather exposure which is sometimes exacerbated by other factors such as irrigation overspray abuse and lack of preventive maintenance. Recommendation and costs shown here are based on replacement with similar style and material. However the client might want to consider replacing with more sturdy lower-maintenance products like composite vinyl etc. Although installation costs are higher total life cycle cost is lower due to less maintenance and longer design life expectancy.

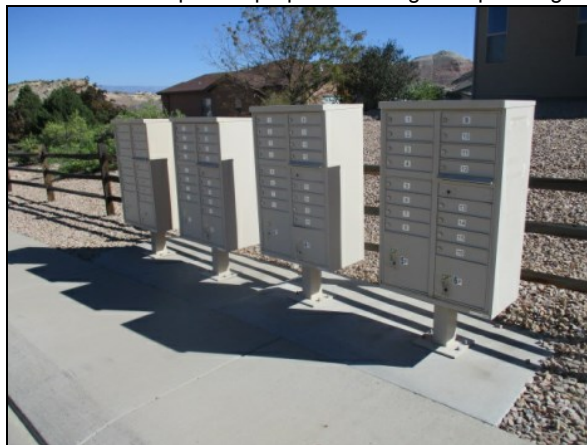
**Comp #: 21600 Mailbox Kiosks - Replace**

Comments: Mailbox kiosks determined to be in fair condition typically exhibit minor to moderate surface wear at this stage. All components and hardware appear to function properly but appearance is diminishing. Inspect regularly and clean by wiping down exterior surfaces. If necessary change lock cylinders lubricate hinges and repair as an Operating expense. Best to plan for total replacement at roughly the time frame below due to constant exposure usage and wear over time. Note USPS has a limited budget for replacement and should not be relied upon for purposes of long term planning.

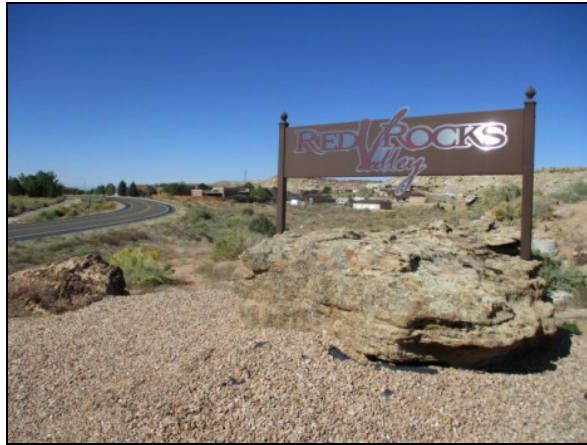
Comments: Monument signage determined to be in fair condition typically exhibits acceptable appearance and aesthetics in keeping with local area but with more weathering and wear showing on surfaces. If present landscaping and lighting are still in serviceable condition. At this stage signage may be becoming more dated and diminishing in appeal. As routine maintenance inspect regularly clean/touch-up and repair as an Operating expense. Plan to refurbish or replace at the interval below. Timing and scope of refurbishing or replacement projects is subjective but should always be scheduled in order to maintain good curb appeal. In our experience most clients choose to refurbish or replace signage periodically in order to maintain good appearance and aesthetics in keeping with local area often before signage is in poor physical condition. If present concrete walls are expected to be painted and repaired as part of refurbishing but not fully replaced unless otherwise noted. Costs can vary significantly depending on style/type desired and may include additional costs for design work landscaping lighting water features etc. Reserve Study updates should incorporate any estimates or information collected regarding potential projects.
