Stormwater Drainage Project for HOA Properties in Red Rocks Valley Community

Stormwater Maintenance Project

Maintenance Project to Main Detention Pond & Stormwater Channel

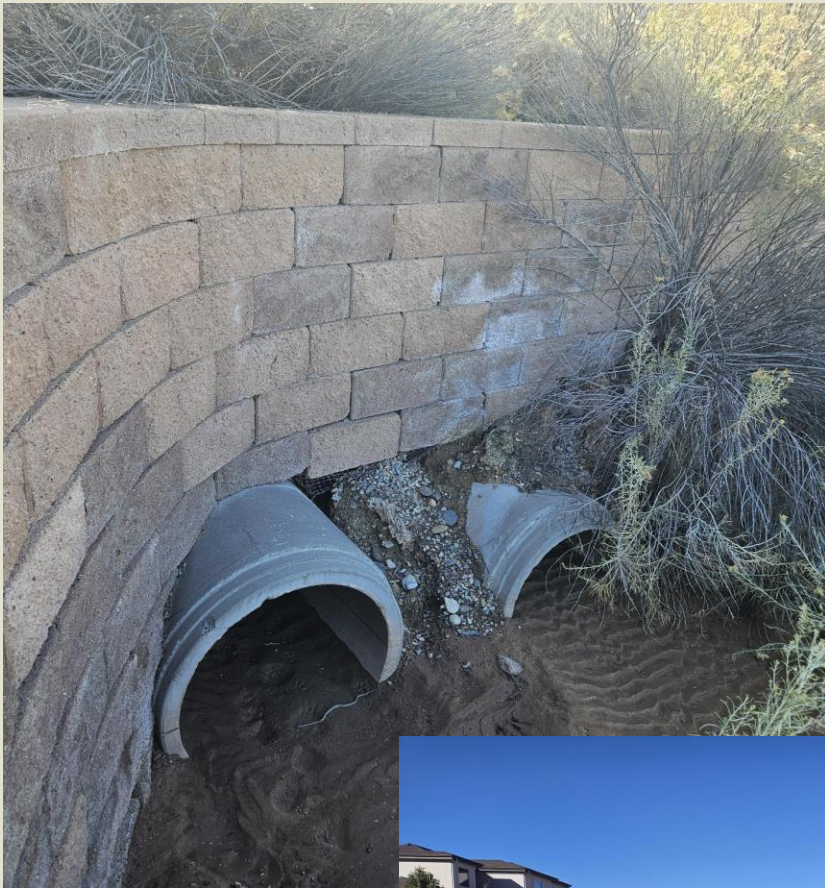
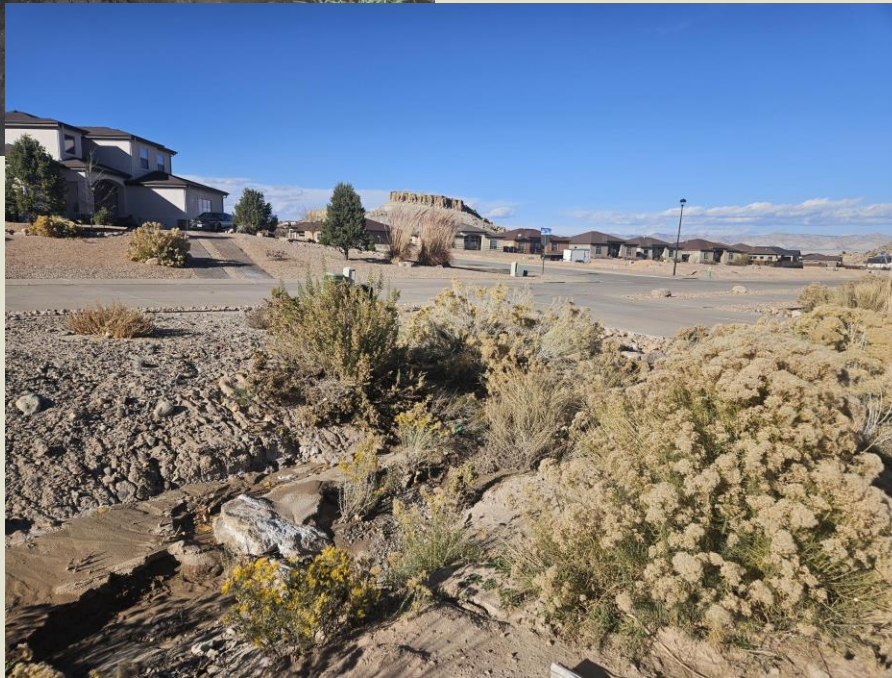
Flow Through Culverts

Larger culverts were designed for locations where stormwater is intended to go under driveways or streets.

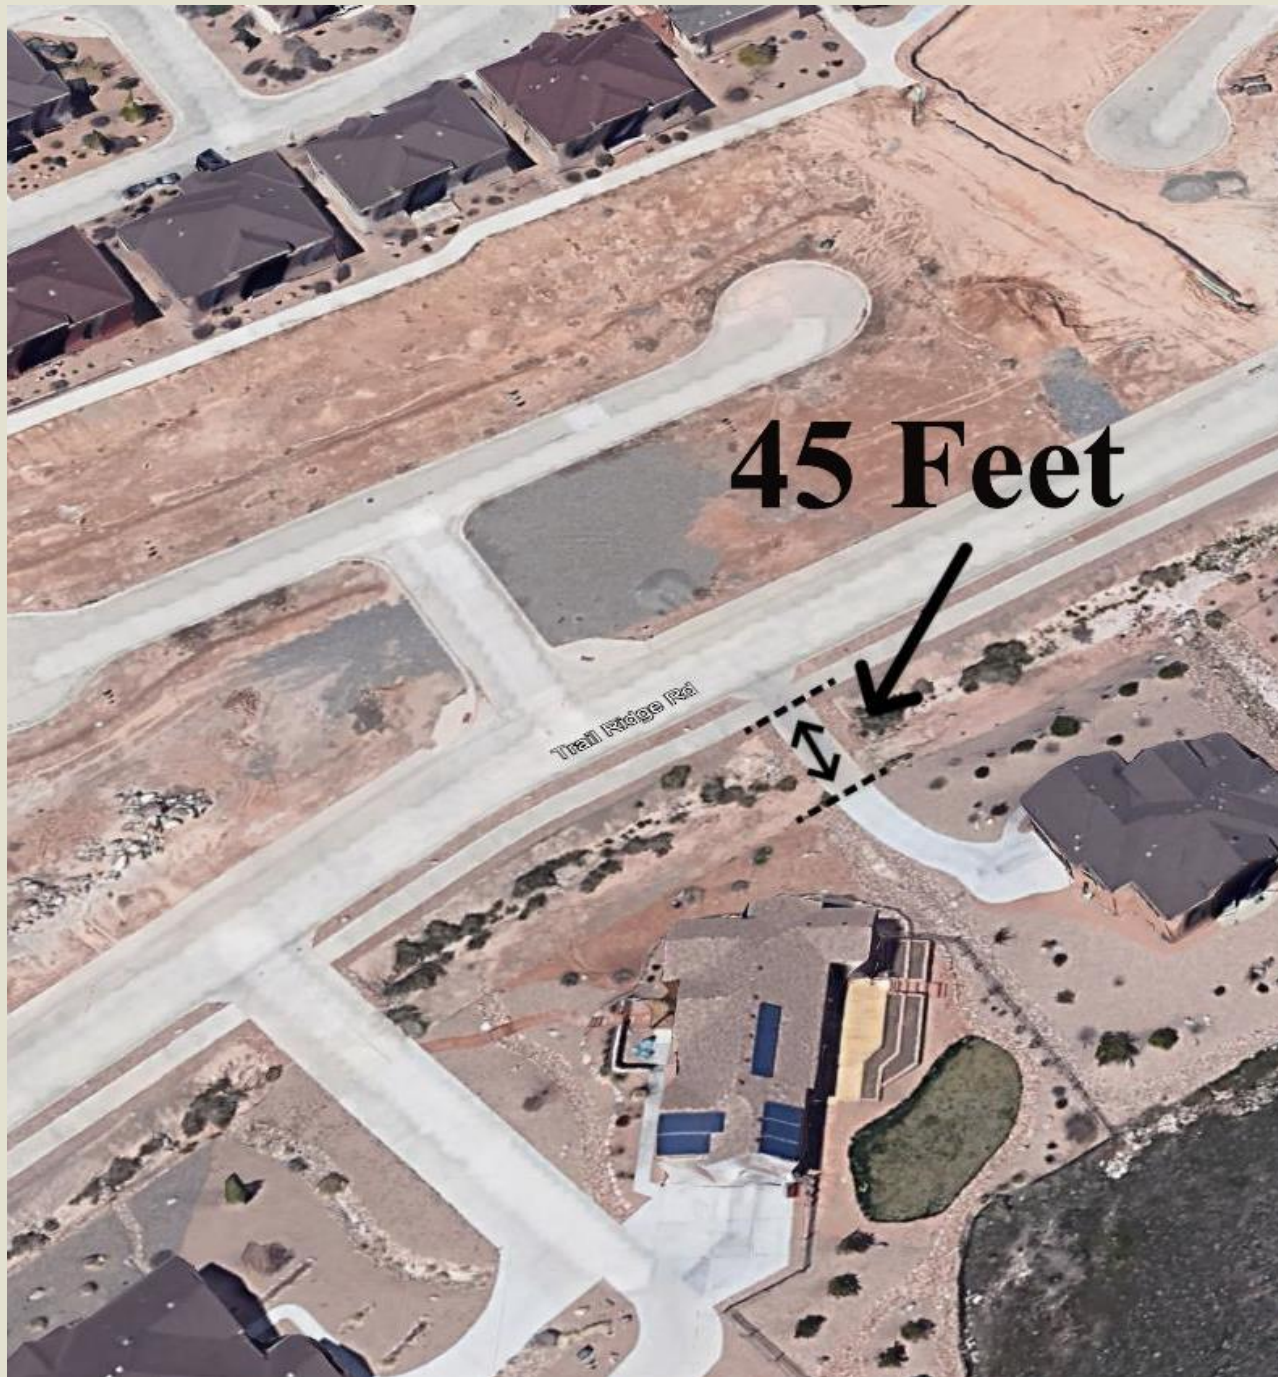
Sedimentation and Water Quality

The system's original design encourages sedimentation which improves water quality before it enters city stormwater system or natural waterways as required by the city of Grand Junction. .

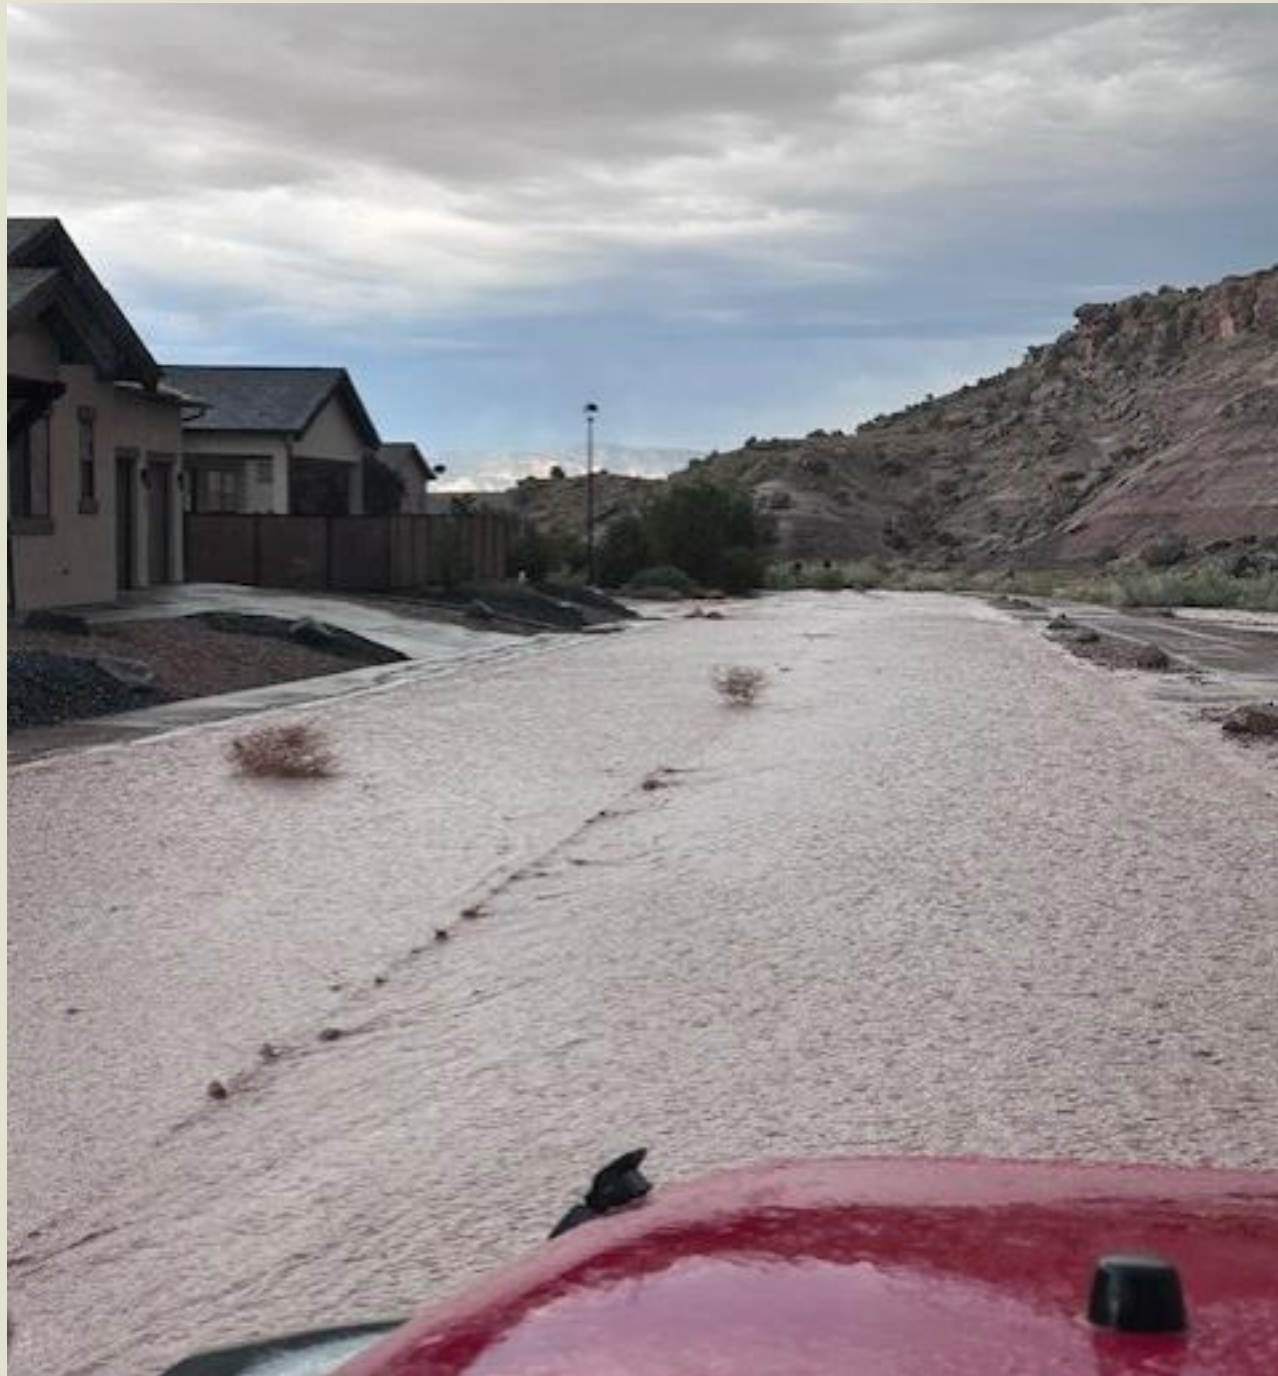
Environmental and Infrastructure Effects

Unmanaged stormwater infrastructure has caused soil erosion, and sediment buildup in the drainage channel and the main detention pond.

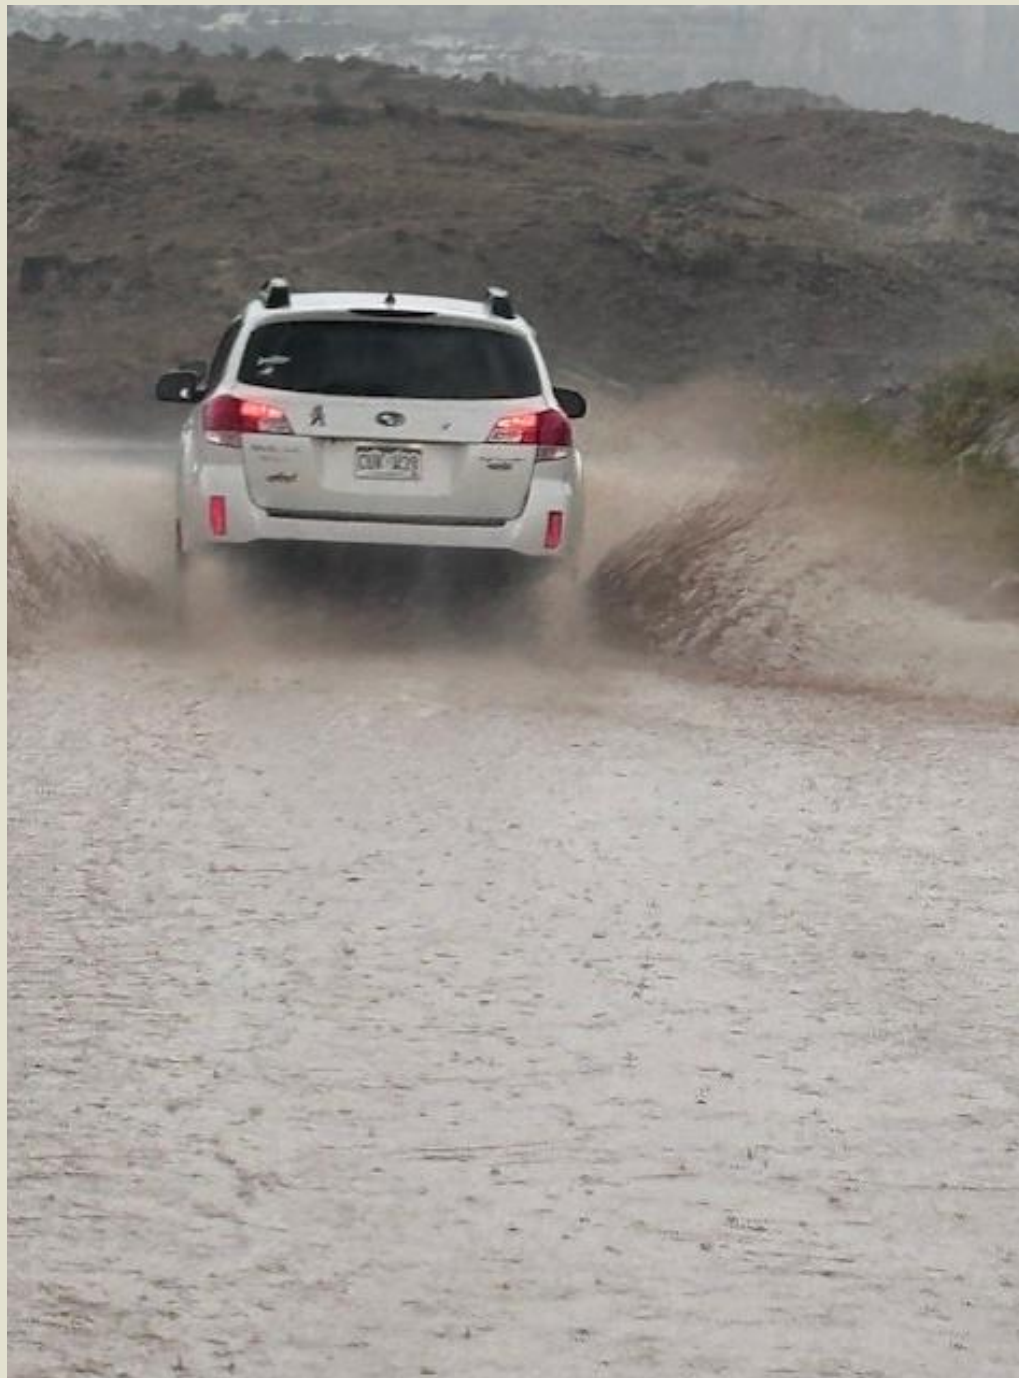
Design Capacity

The stormwater system was designed for a 100 year flood that can occur over 24 hours with rainfall amounts of 2.01 inches for the 2007 original hydraulic analysis and updated in 2013 to 2.6 inches.

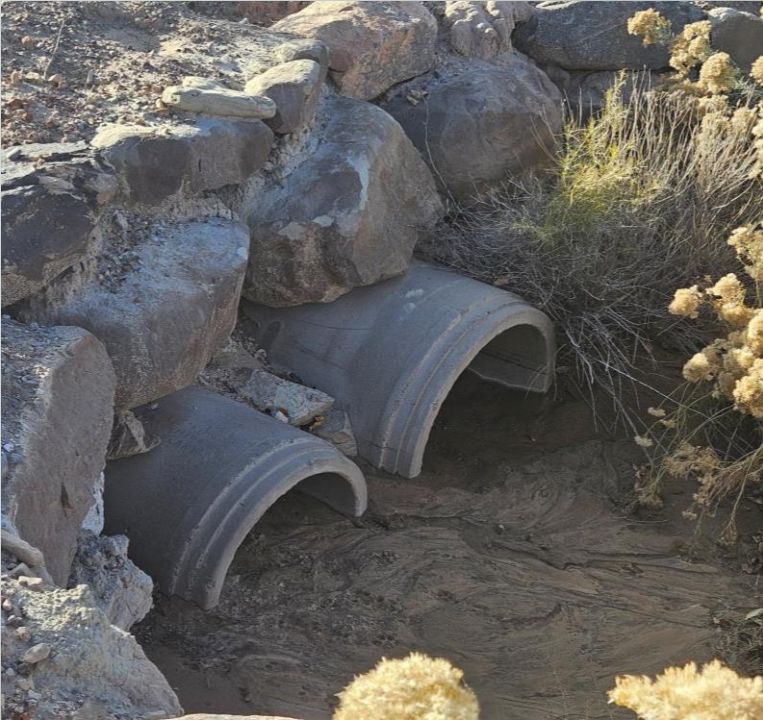
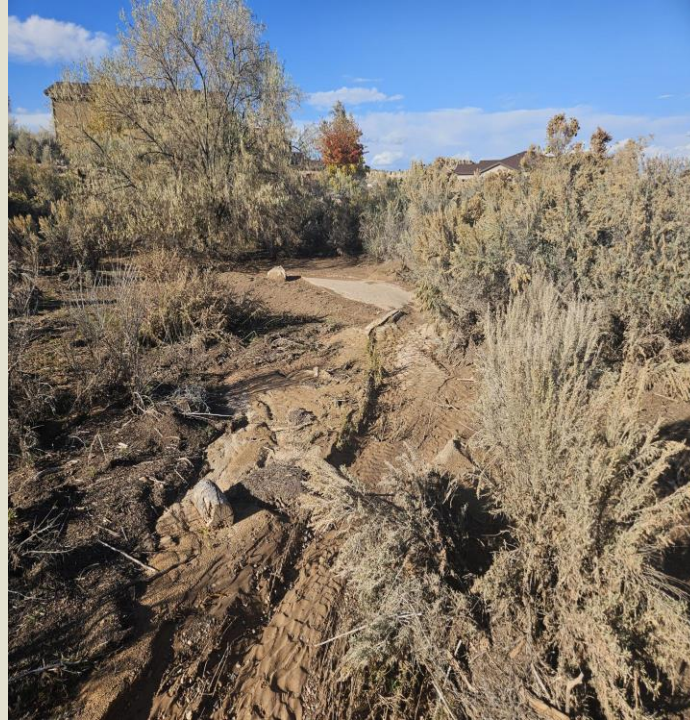
- Detention system overflowed onto street and properties along Trail Ridge Road.
- Stormwater sheet flowed onto undeveloped Red Vale Ct and Rocky Knoll Ct properties knocking down retaining wall.
- Several crawlspaces were flooded
- Landscaping was washed away
- Walking paths washed away
- Additional substantial sediment and mud inundated stormwater system

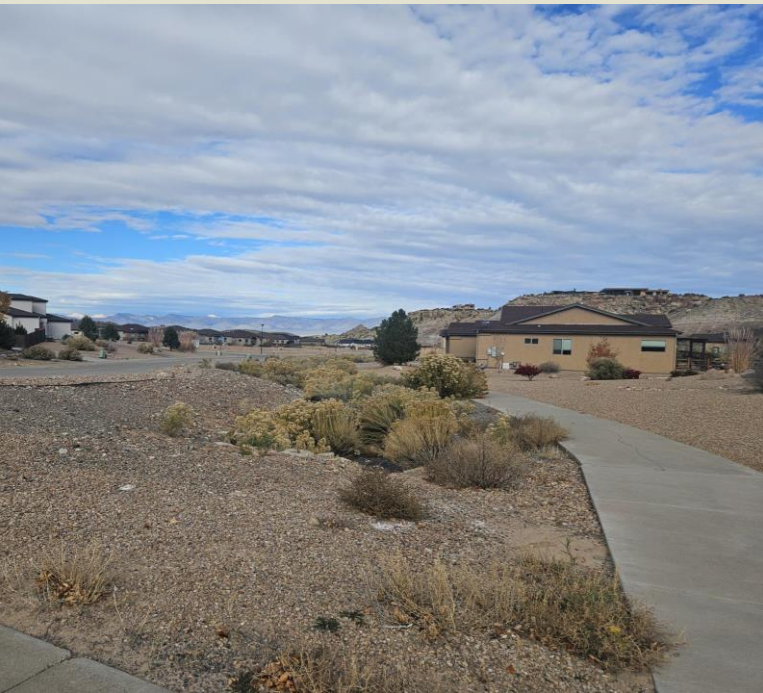
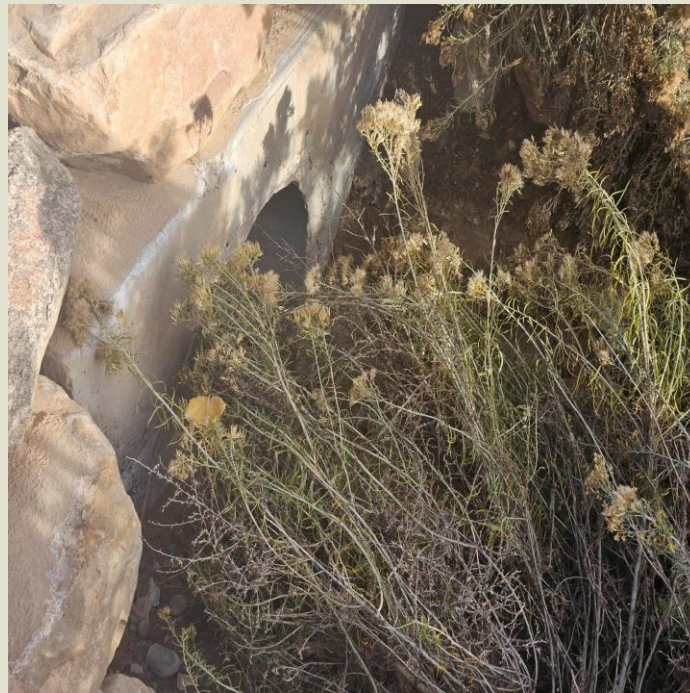
One driveway was not constructed to design and created a major choke point

Stormwater sheet flowed across the undeveloped property, creating additional flooding

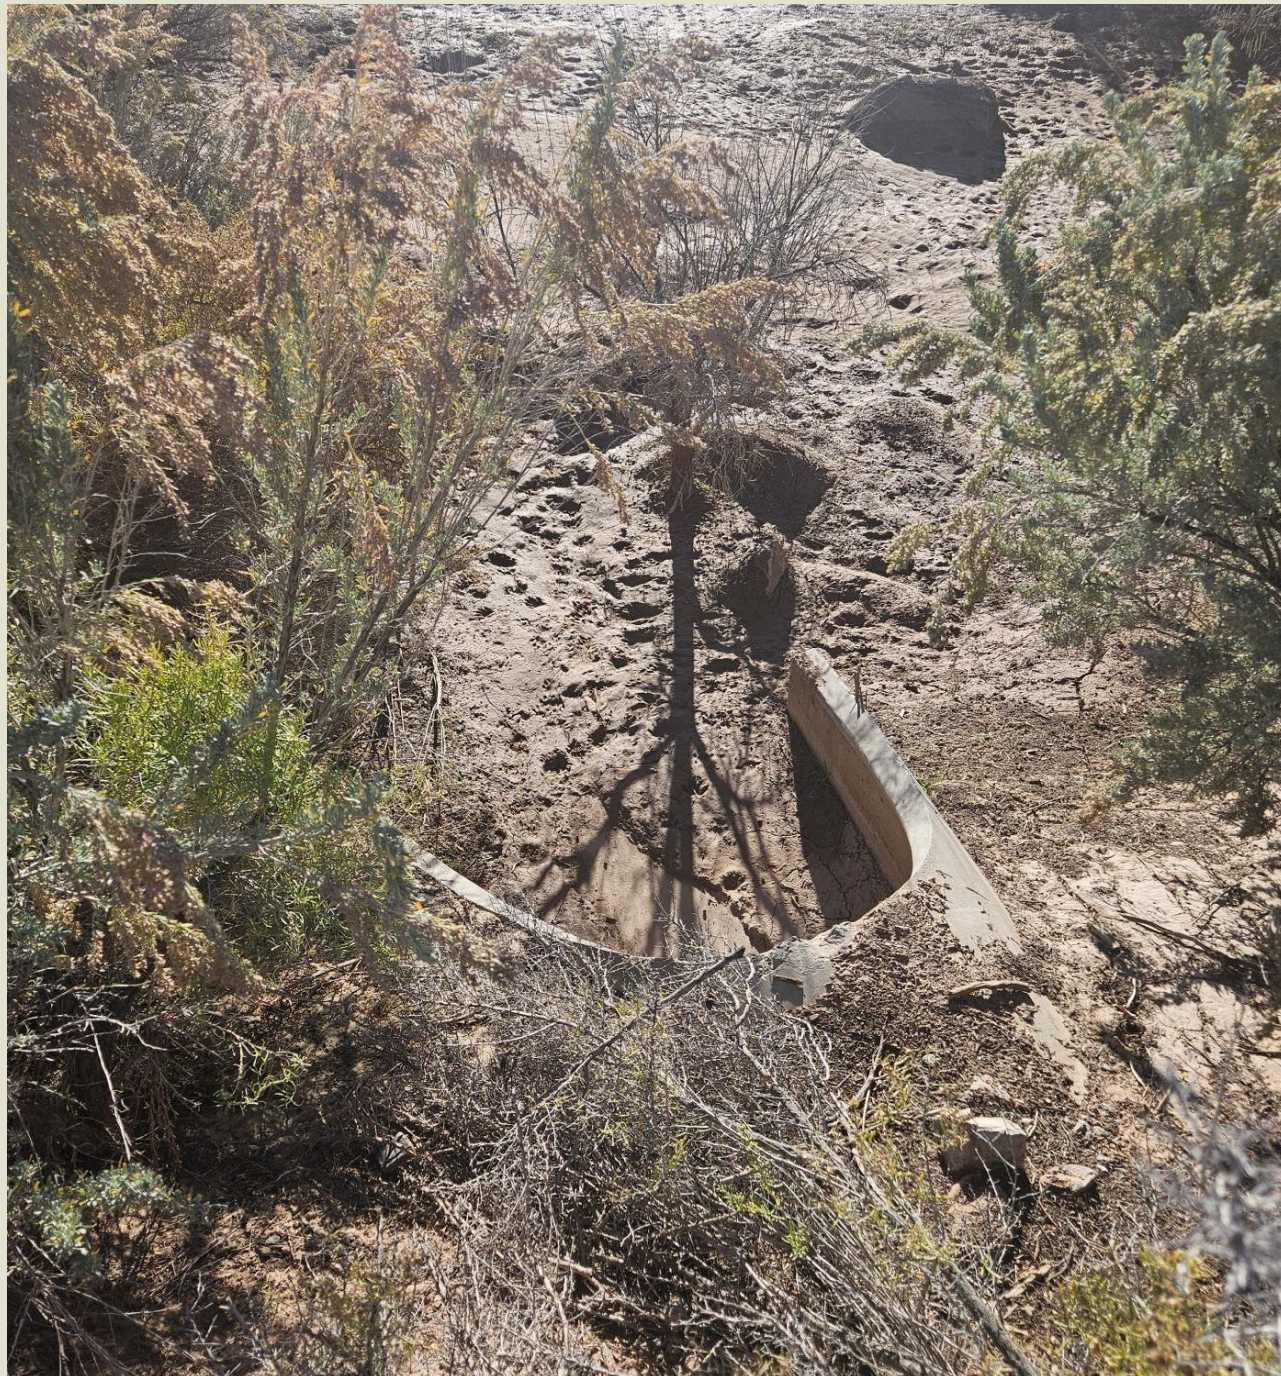
After reviewing the initial damage from the Sept 4th flash flood, the following plan was approved by the HOA Board, and a contractor was hired to:

- Repair work needed to occur prior to the next rain season
- After verifying with city, the existing stormwater system needed vegetation removed
- Remove sediment and regrade
- Clean all culverts

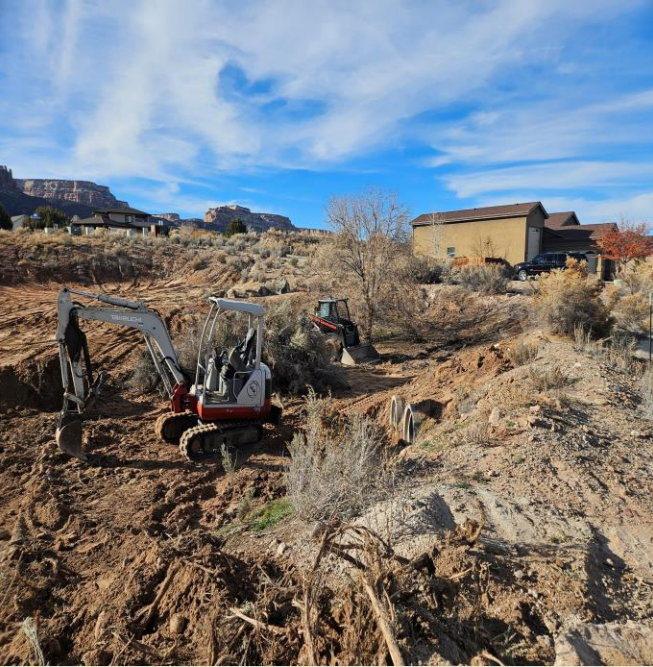
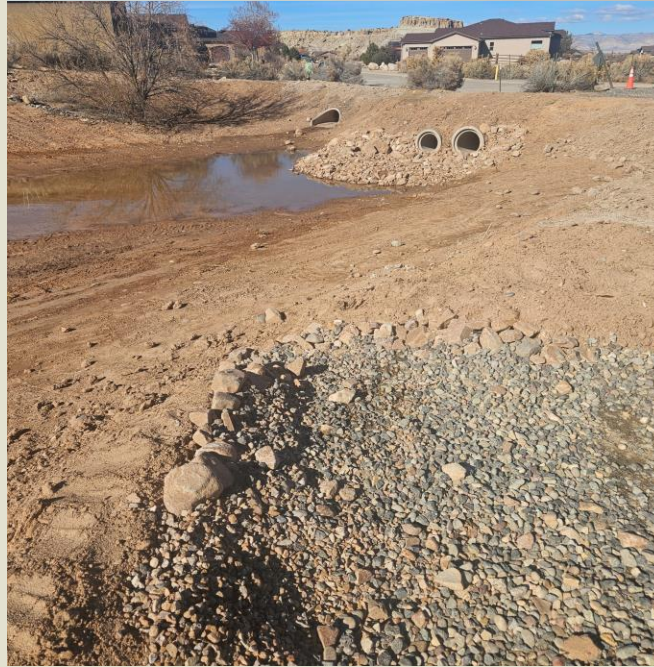
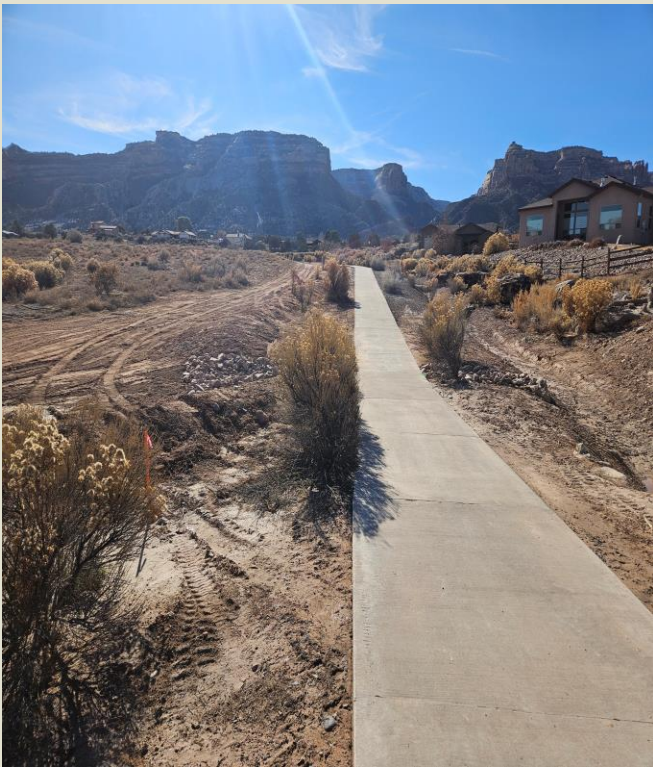
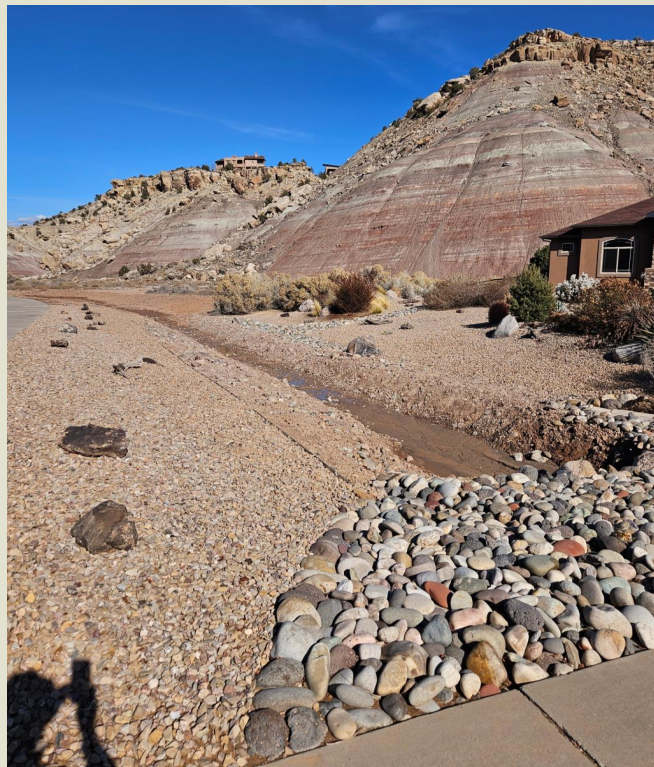
- Dredging removed sediment buildup, restoring the pond's original water storage capacity.
- Excavating beyond original design where possible to add greater capacity.
- Berms added and repaired at main detention pond and open space sidewalk below.
- End of drainage channel has been cleared and open graded into adjacent property

All culverts were jetted and cleaned out as previously they were up to 75% blocked.

Most Rabbitbrush, and all evasive vegetation removed

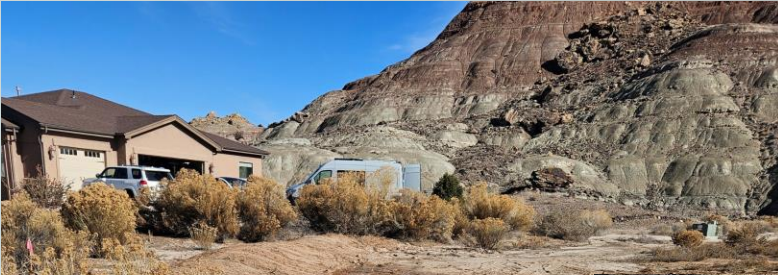
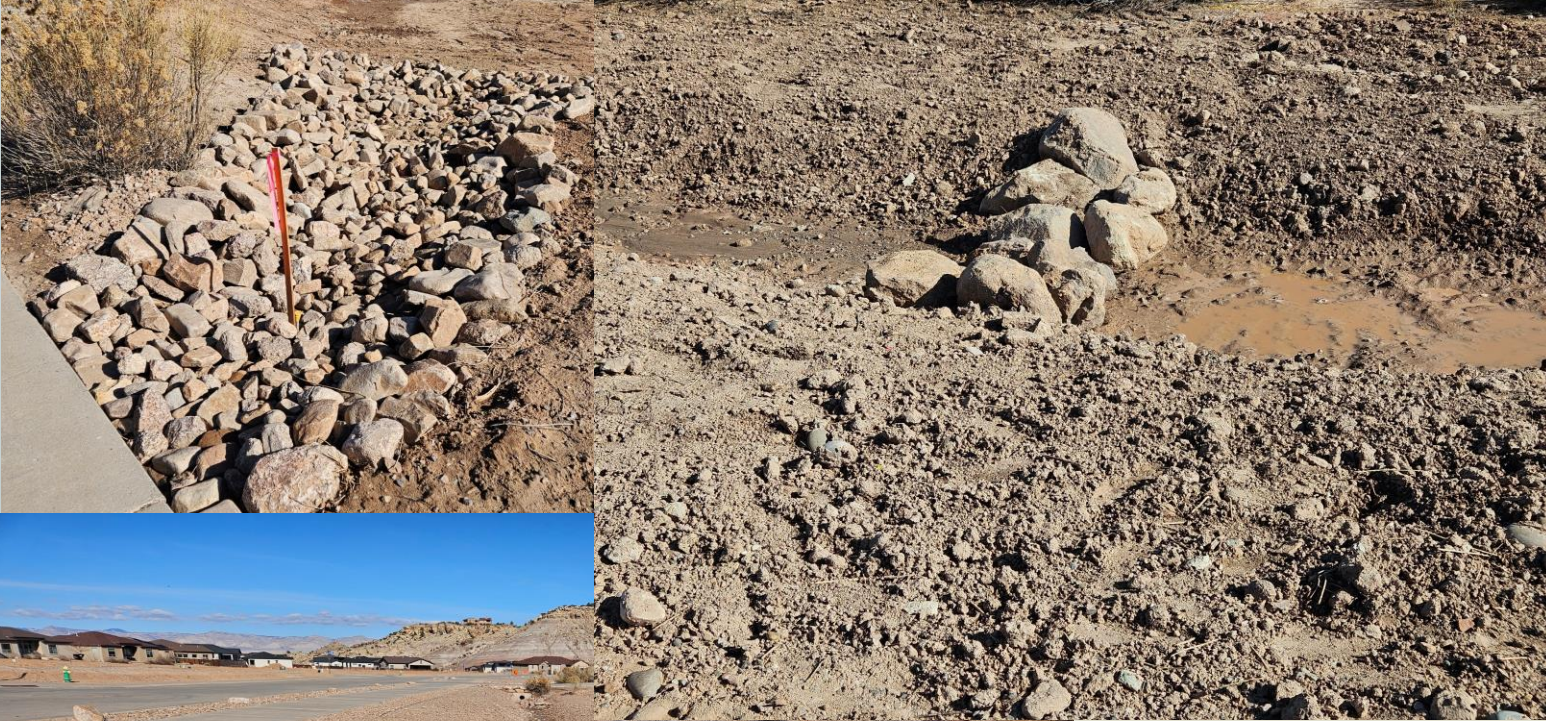
Rock Reinforcement and Landscaping Repairs

Rip rap (jagged rock) was added at culverts and sides of driveway to slow erosion.

Check dams (linear rock) was added to slow down and help control water flow.

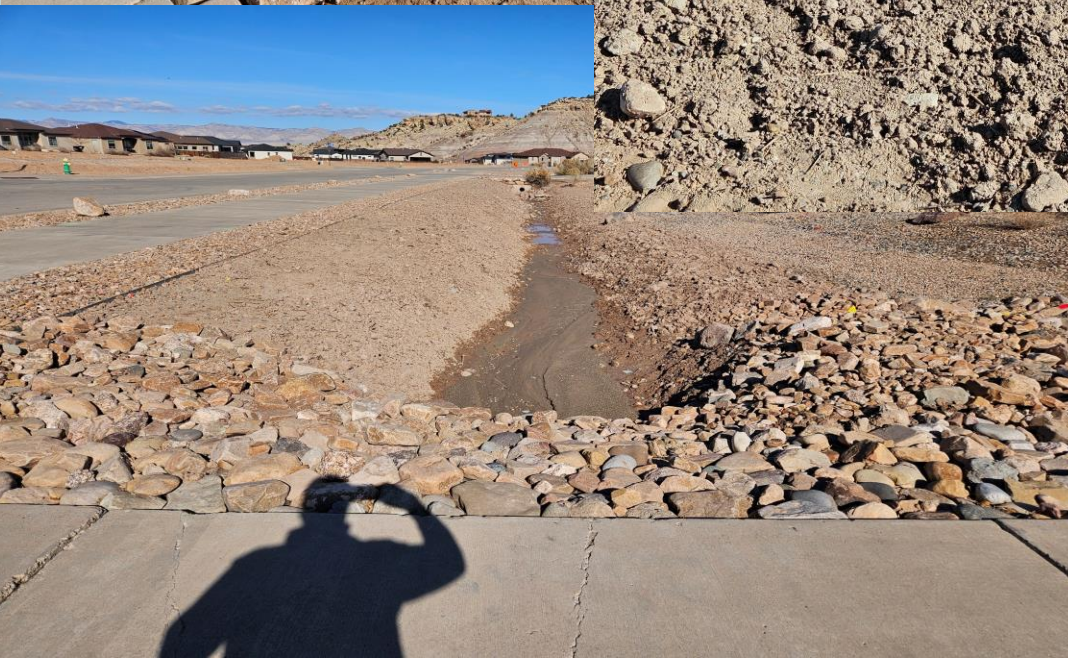
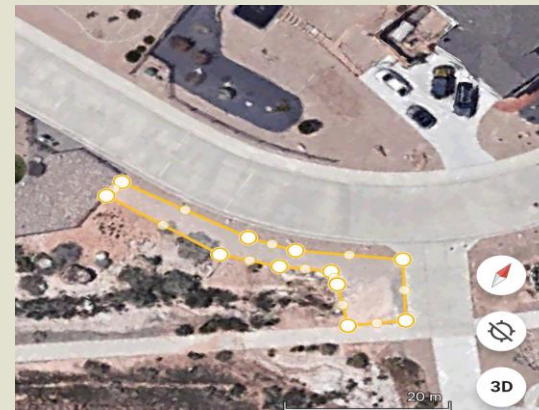
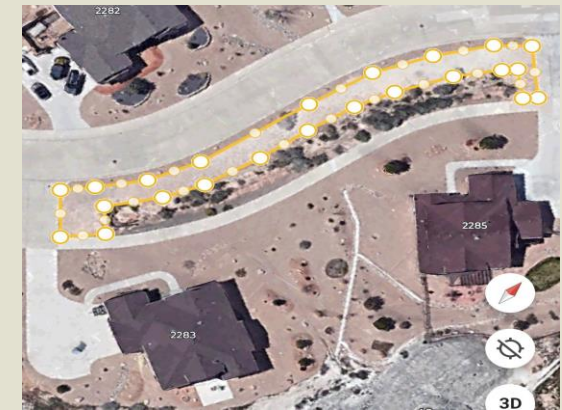
Most areas replaced where wash out occurred

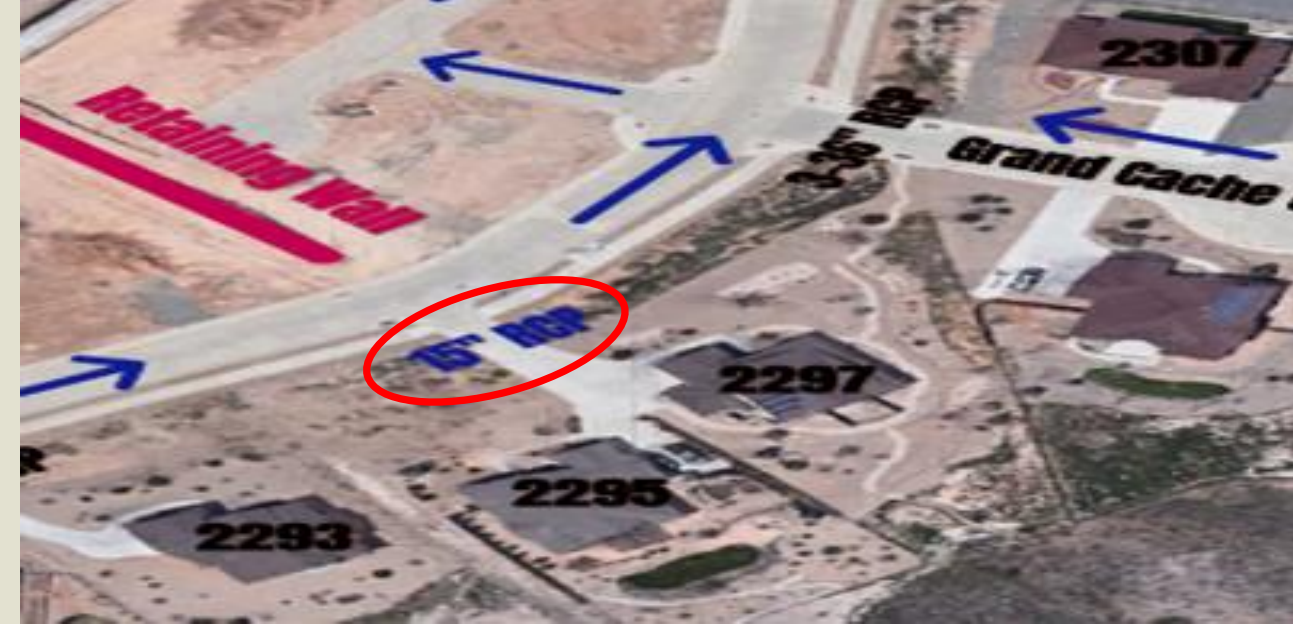
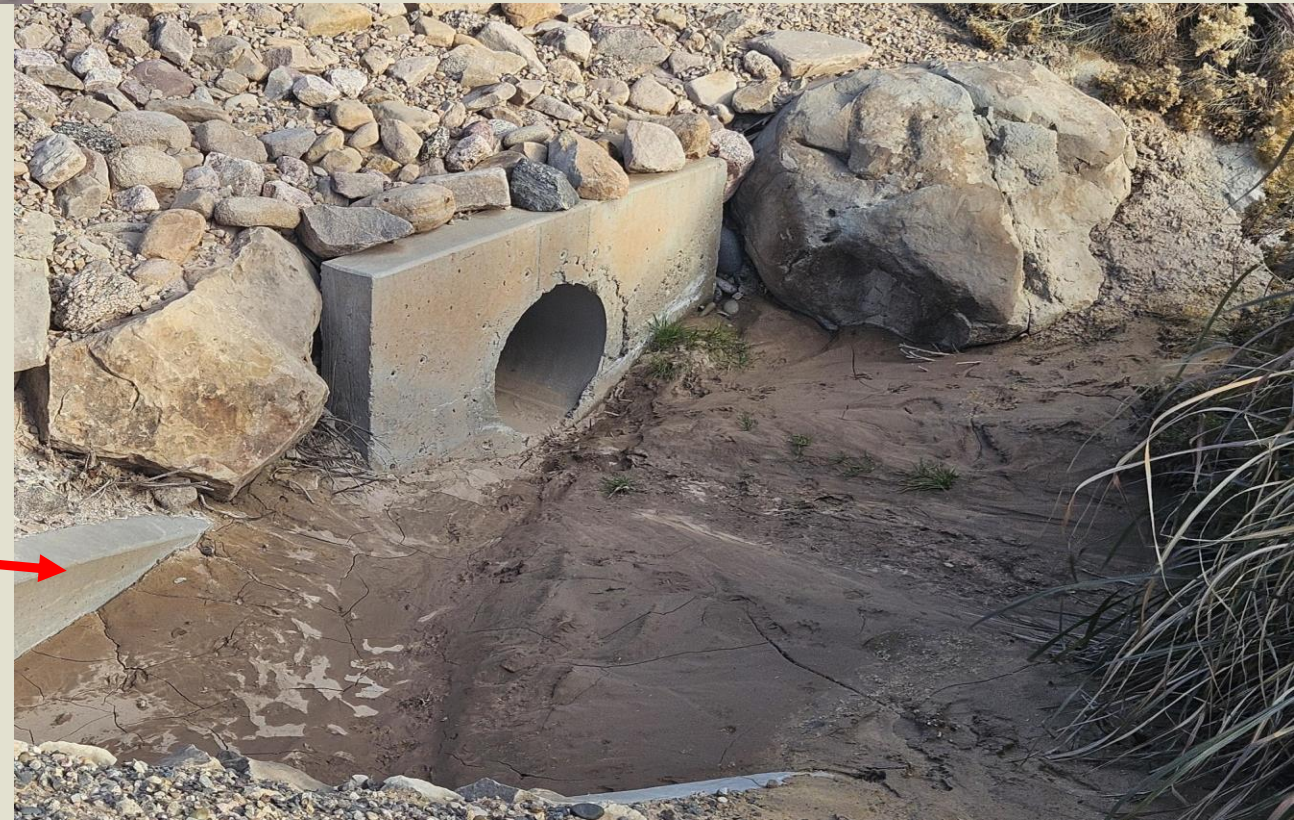
Culvert Addition

- In flash floods, this channel location is more quickly overwhelmed.
- Additional stormwater breaches into Trail Ridge and across to cul-de-sacs
- Stormwater flooded adjacent homeowner lots up to front door

- Designed as a linear detention pond & 15" culvert
- However, driveway was constructed incorrectly over drainage channel at a substantially higher elevation
- Street stormwater outlet is directly above upstream culvert adding stormwater volume
- Major stormwater channel is within 100 feet
- Main Choke Point in the Drainage Channel

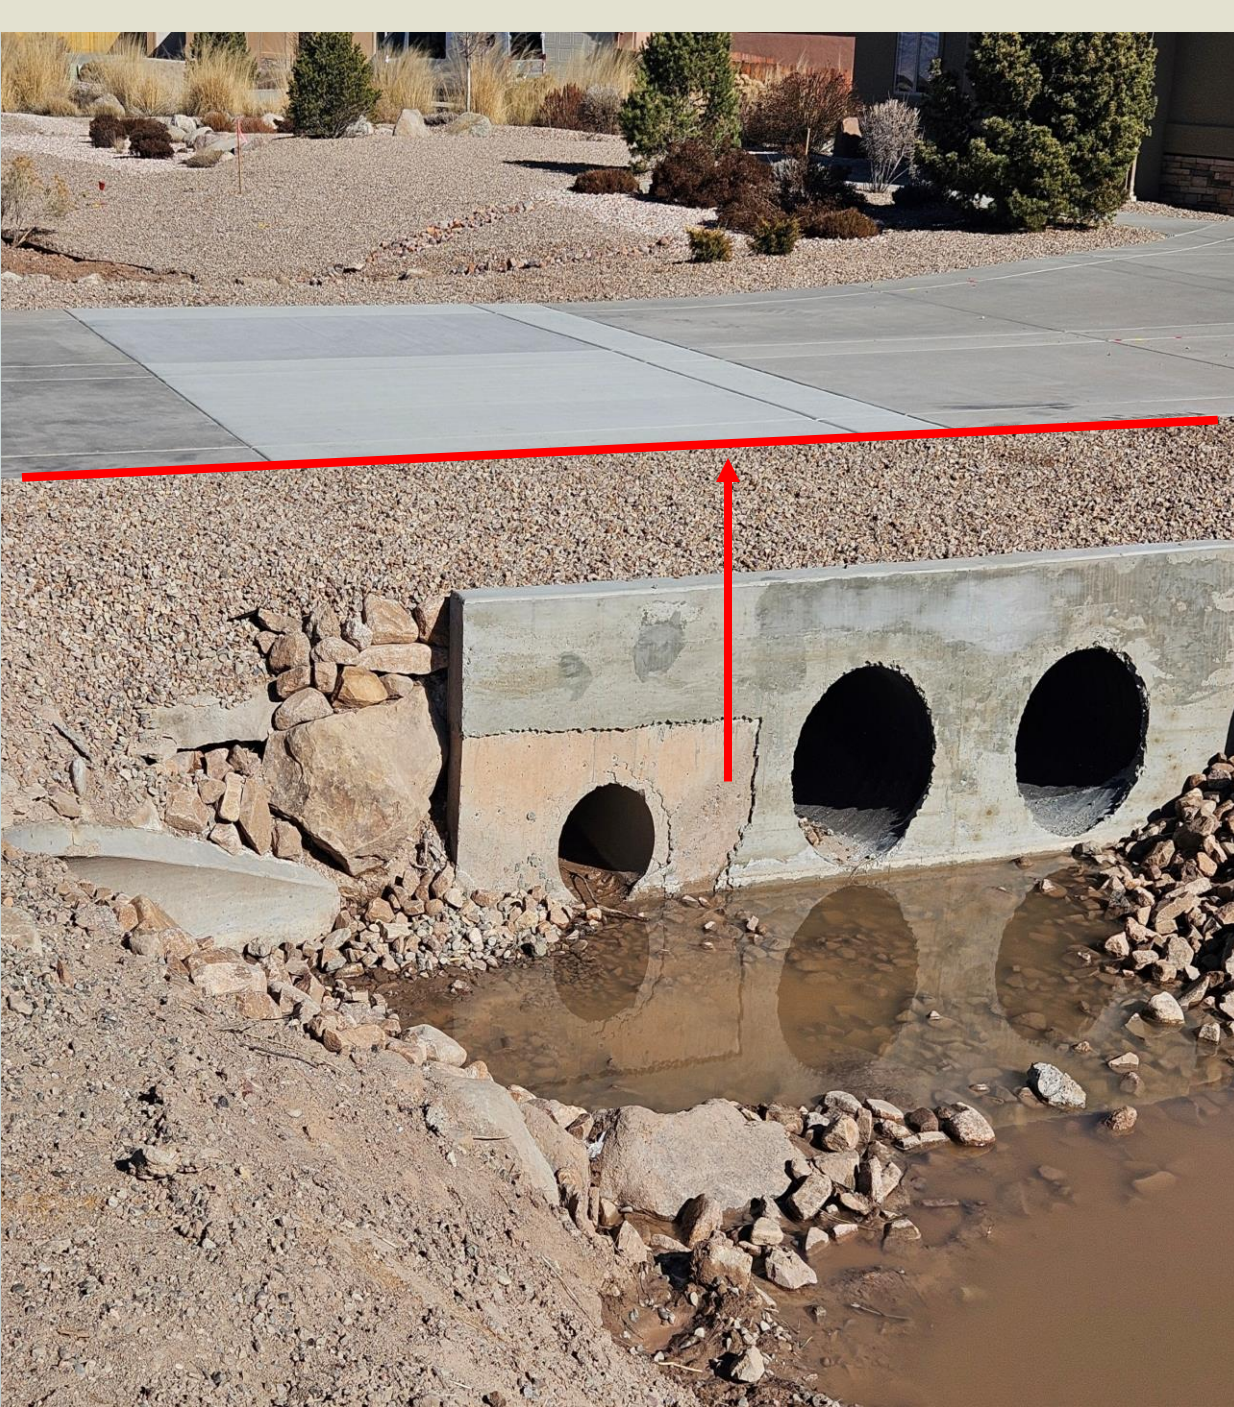
Purpose and Design of the New Culvert

Added 2 - 30" culverts and concrete headwall to existing 15" culvert to allow stormwater to easily flow underneath driveway and not overflow into street and adjacent property.

Working with the contractor and the engineer during construction it was determined that adding culverts to this location would provide the greatest impact for stormwater flood reduction in the system.

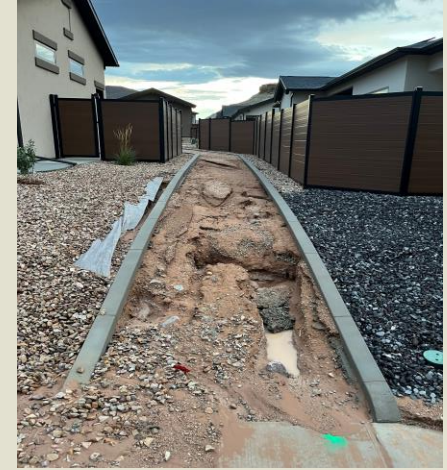
Miscellaneous Repairs to HOA property

Wall was repaired
