**Sundance Crossing OA**  
***Grand Junction, CO***

Report #: 48495-0  
Beginning: January 1, 2024  
Expires: December 31, 2024

**RESERVE STUDY**  
**"Full"**

August 30, 2023

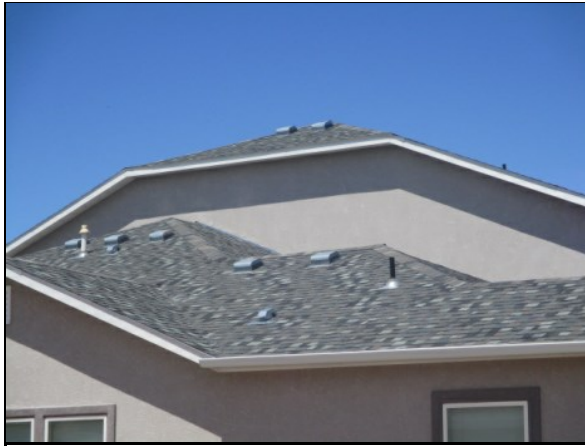
**Comp #: 23570 Roof: Comp Shingle - Replace (2021)****Quantity: ~ 53900 GSF**

Comments: Includes buildings 615 (531-540), 612, 614, 612 (Mesa), 616, and 620. Closed valleys were observed. Ventilation (the lack of which can greatly reduce the roof's useful life) was observed at the eave and ridge. Eave venting consisted of soffit holes between the rafters. Ridge venting appeared to be provided by roof jacks and gable end louvers. Debris was not observed on the roof surface. Asphalt shingle roofs determined to be in fair condition and typically exhibit normal signs of wear and deterioration including some loss of granule cover and light to moderate curling/lifting especially in most exposed areas. Overall believed to be aging normally. A reserve study conducts only a limited visual review and many of the critical waterproofing and ventilation items of the roof are not readily viewable. For a full evaluation have a professional roof consultant/contractor perform a thorough up-close survey of your entire roof system including attic inspection (if any). Costs below factors replacement with an architectural grade laminated shingle. As routine maintenance many manufacturers recommend inspections at least twice annually (once in the fall before the snow season and again in the spring) and after large storm events. Promptly replace any damaged/missing sections or any other repair needed to ensure waterproof integrity of roof. Keep roof surface gutters and downspouts clear and free of debris. At the time of re-roofing we recommend that you hire a professional consultant to evaluate the existing roof and specify the new roof materials/design provide installation oversight. We recommend that all clients hire qualified consultants whenever they are considering having work performed on any building envelope (waterproofing) components including: roof walls windows decks exterior painting and caulking/sealant. There is a wealth of information available through Roofing Organizations such as: National Roofing Contractors client (NRCA) <http://www.nrca.net>. Asphalt Roofing Manufacturers client (ARMA) <http://www.asphaltroofing.org/> Roof Consultant Institute (RCI) <http://www.rci-online.org>

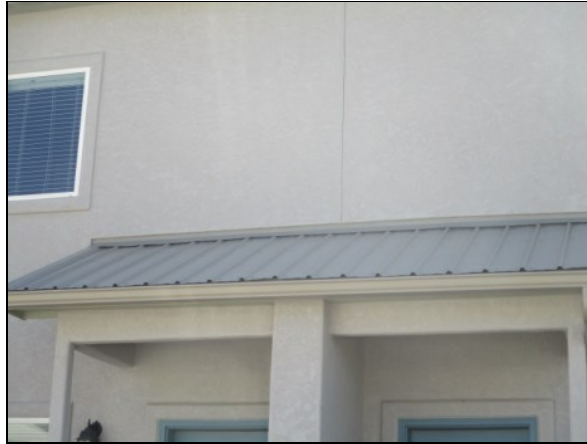
**Comp #: 23600 Roof: Metal - Replace****Quantity: ~ 770 GSF**

Comments: Includes Buildings 612 and 616 Canyon Vista Way. Roofing consists of Pro-Panel metal roof. Typically metal roofs are either Pro-Panel seamed roofs or Standing Seam roofs. Pro-Panel roofs are installed with exposed metal screws and fasteners while Standing Seam will snap lock panels over the mechanical seam with no penetrations to the underlayment. Advantages of metal roofs include long life expectancies with relatively low need to repair. Metal roofing is typically a long-lived component assuming it was properly installed and is properly maintained. As routine maintenance many manufacturers recommend inspections at least twice annually (once in the fall before the rainy season and again in the spring) and after large storm events. Promptly replace any damaged/missing sections or conduct any other repair needed to ensure waterproof integrity of roof. We recommend having roof inspected in greater detail (including conditions of sub-surface materials) by an independent roofing consultant prior to replacement. There is a wealth of information available through organizations such as the Roof Consultant Institute <http://www.rci-online.org> and the National Roofing Contractors client (NRCA) <http://www.nrca.net/>. If the roof has a warranty be sure to review terms and conduct proper inspections/repairs as needed to keep warranty in force.

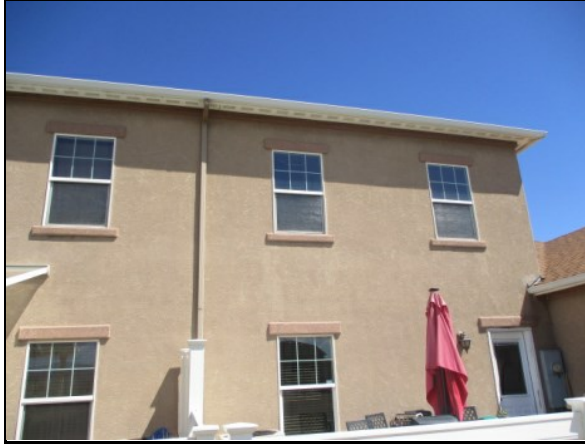
**Comp #: 23650 Gutters/Downspouts - Replace (2008)****Quantity: ~ 1700 LF**

Comments: Gutters and downspouts determined to be in fair condition typically exhibit some normal wear and tear but drainage away from the roof and building appears to be adequate. Generally believed to be aging normally. Gutters and downspouts are assumed to be functioning properly unless otherwise noted. As routine maintenance inspect regularly keep gutters and downspouts free of debris. If buildings are located near trees keep trees trimmed back to avoid accumulation of leaves on the roof surface which will accumulate in the gutters and increase maintenance requirements while reducing life expectancy. Repair or replace individual sections as needed as an Operating expense. We generally recommend that the gutters and downspouts be replaced when the roof is being resurfaced/replaced. National Roofing Contractor client (NRCA) roofing standard includes installing eave flashings at the gutters. We suggest to plan for total replacement of gutter and downspouts at the same intervals as roof replacement for cost efficiency. Unless otherwise noted costs shown here assume replacement with similar type as are currently in place.

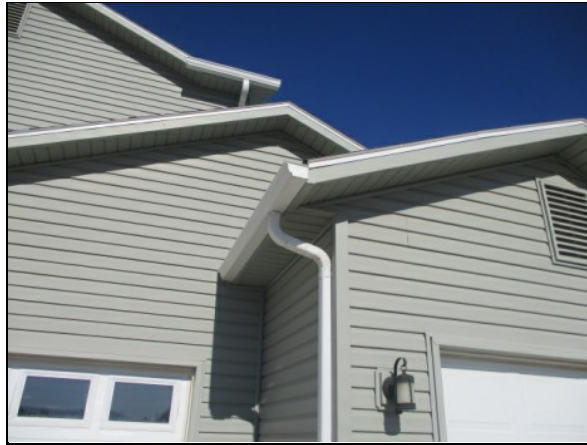
**Comp #: 23650 Gutters/Downspouts - Replace (2019)****Quantity: ~ 1900 LF**

Comments: Gutters and downspouts determined to be in good condition typically exhibit little to no significant surface wear or deterioration of material. No obvious sagging or tilting sections. Attachments to building appear to be strong and stable. Gutters and downspouts are assumed to be functioning properly unless otherwise noted. As routine maintenance inspect regularly keep gutters and downspouts free of debris. If buildings are located near trees keep trees trimmed back to avoid accumulation of leaves on the roof surface which will accumulate in the gutters and increase maintenance requirements while reducing life expectancy. Repair or replace individual sections as needed as an Operating expense. We generally recommend that the gutters and downspouts be replaced when the roof is being resurfaced/replaced. National Roofing Contractor client (NRCA) roofing standard includes installing eave flashings at the gutters. We suggest to plan for total replacement of gutter and downspouts at the same intervals as roof replacement for cost efficiency. Unless otherwise noted costs shown here assume replacement with similar type as are currently in place.

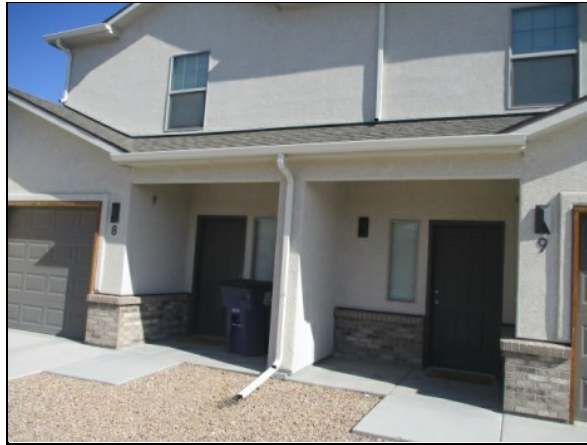
**Comp #: 23650 Gutters/Downspouts - Replace (2020)****Quantity: ~ 1700 LF**

Comments: Gutters and downspouts determined to be in good condition typically exhibit little to no significant surface wear or deterioration of material. No obvious sagging or tilting sections. Attachments to building appear to be strong and stable. Gutters and downspouts are assumed to be functioning properly unless otherwise noted. As routine maintenance inspect regularly keep gutters and downspouts free of debris. If buildings are located near trees keep trees trimmed back to avoid accumulation of leaves on the roof surface which will accumulate in the gutters and increase maintenance requirements while reducing life expectancy. Repair or replace individual sections as needed as an Operating expense. We generally recommend that the gutters and downspouts be replaced when the roof is being resurfaced/replaced. National Roofing Contractor client (NRCA) roofing standard includes installing eave flashings at the gutters. We suggest to plan for total replacement of gutter and downspouts at the same intervals as roof replacement for cost efficiency. Unless otherwise noted costs shown here assume replacement with similar type as are currently in place.

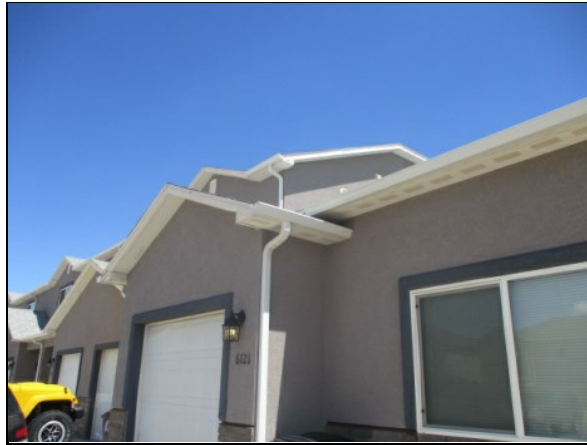
**Comp #: 23650 Gutters/Downspouts - Replace (2021)****Quantity: ~ 3900 LF**

Comments: Gutters and downspouts determined to be in good condition typically exhibit little to no significant surface wear or deterioration of material. No obvious sagging or tilting sections. Attachments to building appear to be strong and stable. Gutters and downspouts are assumed to be functioning properly unless otherwise noted. As routine maintenance inspect regularly keep gutters and downspouts free of debris. If buildings are located near trees keep trees trimmed back to avoid accumulation of leaves on the roof surface which will accumulate in the gutters and increase maintenance requirements while reducing life expectancy. Repair or replace individual sections as needed as an Operating expense. We generally recommend that the gutters and downspouts be replaced when the roof is being resurfaced/replaced. National Roofing Contractor client (NRCA) roofing standard includes installing eave flashings at the gutters. We suggest to plan for total replacement of gutter and downspouts at the same intervals as roof replacement for cost efficiency. Unless otherwise noted costs shown here assume replacement with similar type as are currently in place.

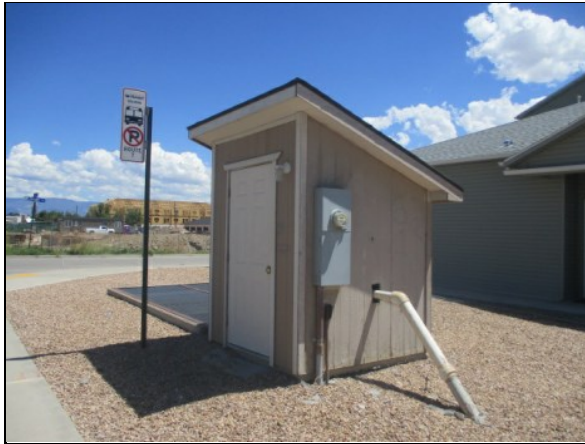
**Comp #: 25560 Irrigation Pump - Repair/Replace****Quantity: ~ (1) Pump**

Comments: Includes (1) 5 HP pump. Minimal or no subjective/aesthetic value for this component. Useful life is based primarily on normal expectations for service/performance life in this location. Unless otherwise noted, remaining useful life expectancy is based primarily on original installation or last replacement/purchase date, our experience with similar systems/components, and assuming normal amount of usage and good preventive maintenance. Irrigation pump(s) can often be repaired or rebuilt rather than completely replaced. Motor rebuilds and other repairs are often considered an Operating expense. Pumps and motors need to be checked and serviced regularly by landscaping/irrigation vendor or other maintenance personnel to ensure proper function. If possible, equipment should be protected from sunlight and weather to minimize exposure and prolong life. Costs to replace are based on similar size and horsepower. If there is more than one pump in place, cost ranges shown below are based on complete replacement of all pumps at one time, usually based on similar/same age and expectation of comparable life expectancy.

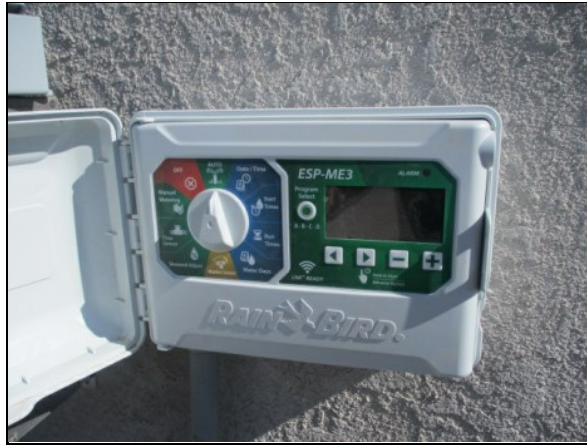
**Comp #: 25570 Irrigation Clocks - Replace**

Comments: Includes (1) Rain Bird, ESP-ME3, August 2022, Bldg. 612, and (1) Rain bird, ESP-ME3, June 2021, Bldg. 614. Minimal or no subjective/aesthetic value for this component. Useful life is based primarily on normal expectations for service/performance life in this location. Unless otherwise noted remaining useful life expectancy is based primarily on original installation or last replacement/purchase date our experience with similar systems/components and assuming normal amount of usage and good preventive maintenance. Irrigation controllers should have a relatively long life expectancy under normal circumstances. Replacement is often required due to lack of available replacement parts lightning strikes etc. as opposed to complete failure of existing equipment. Exposure to the elements can affect overall life expectancy and controllers should be located in protected areas or within protective enclosures whenever possible. When evaluating replacement options the client should consider replacement with smart" models (i.e. respond to projected weather data) to minimize unnecessary water usage. Payback period for efficient controllers that minimize water use is typically very short
